MILESTONE INSPECTION – PHASE I
FOR
PORT BELLEAIR No. 2 CONDOMINIUMS
147 BLUFF VIEW DRIVE
BELLEAIR BLUFFS, FLORIDA 33770

PREPARED FOR:

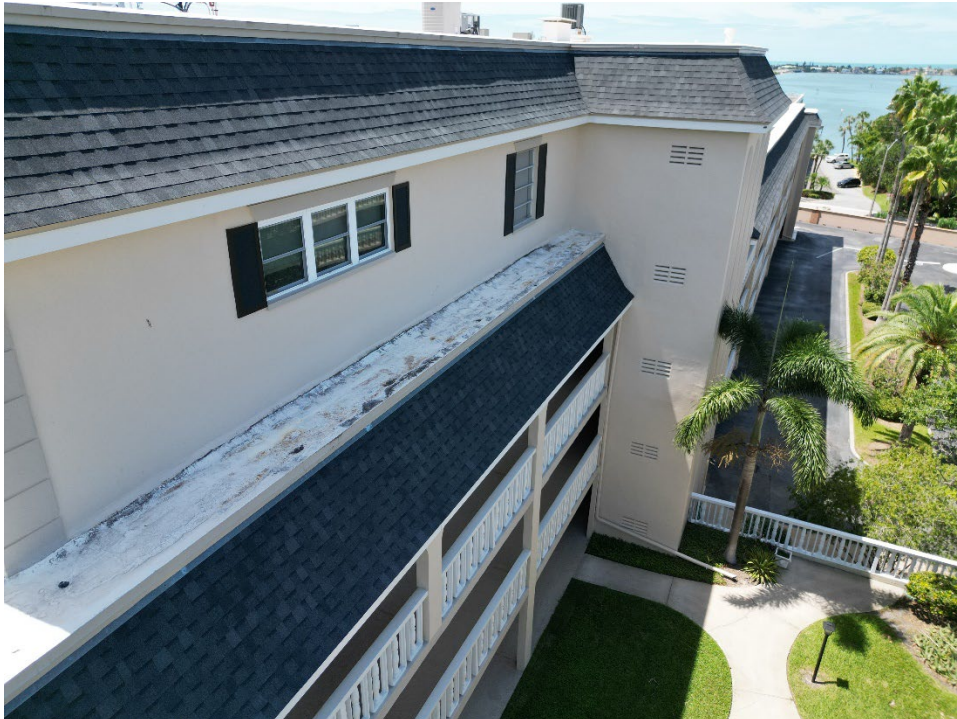
8. An example of significant deterioration on the flat roof, along the north side of the building, on the lower east flat roof.

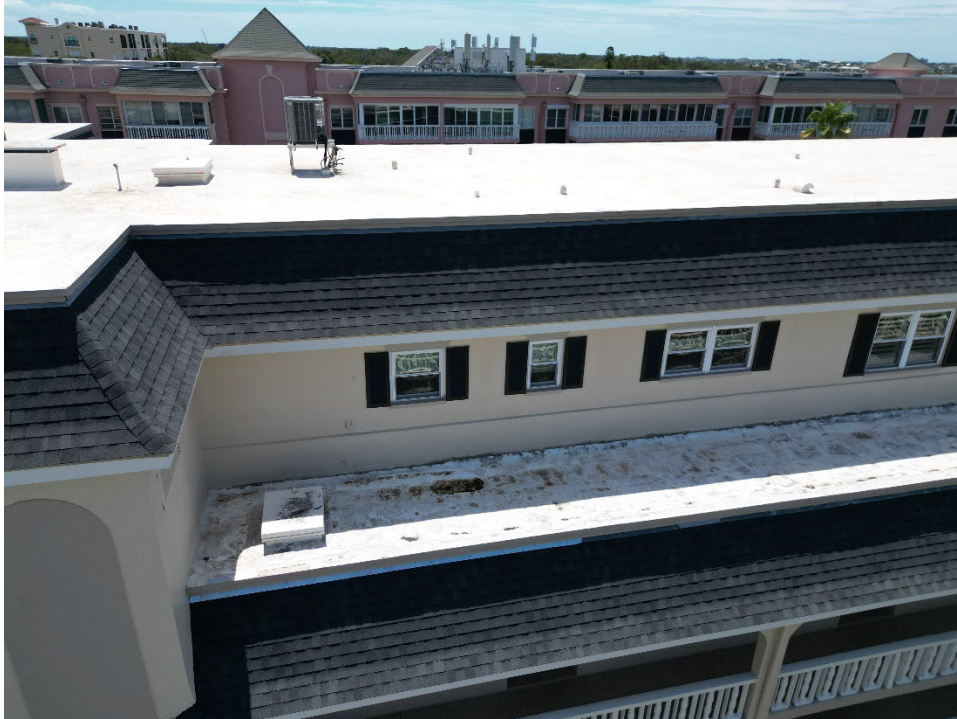
9. An example of significant deterioration on the flat roof, along the north side of the building, on the lower west flat roof.

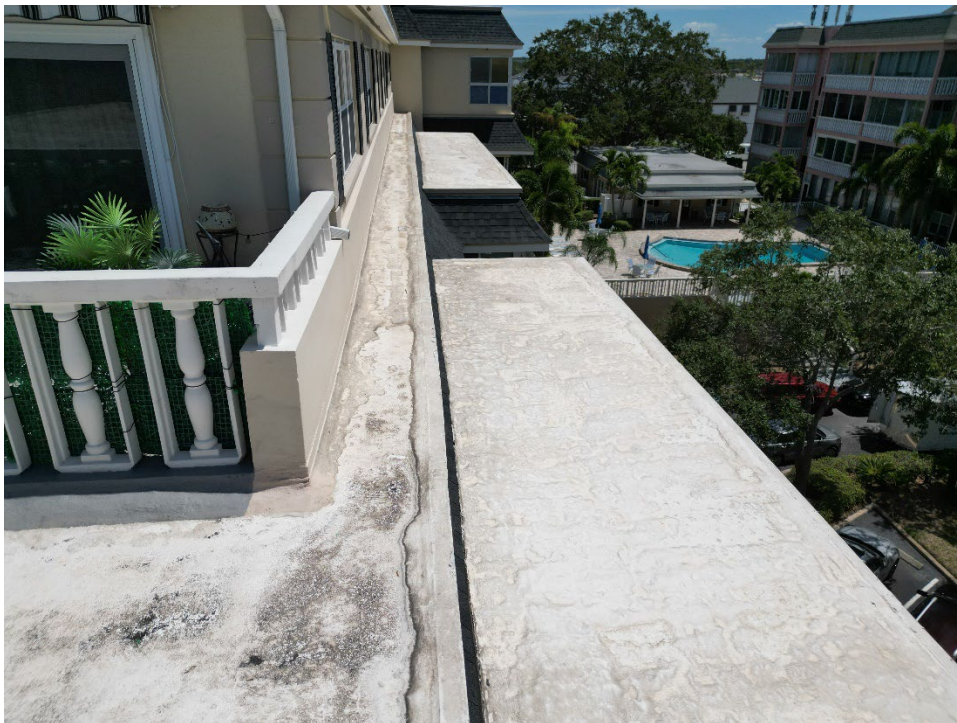
10. An example of significant deterioration on the TPO roof, along the south side of the building, on the lower west flat roof.

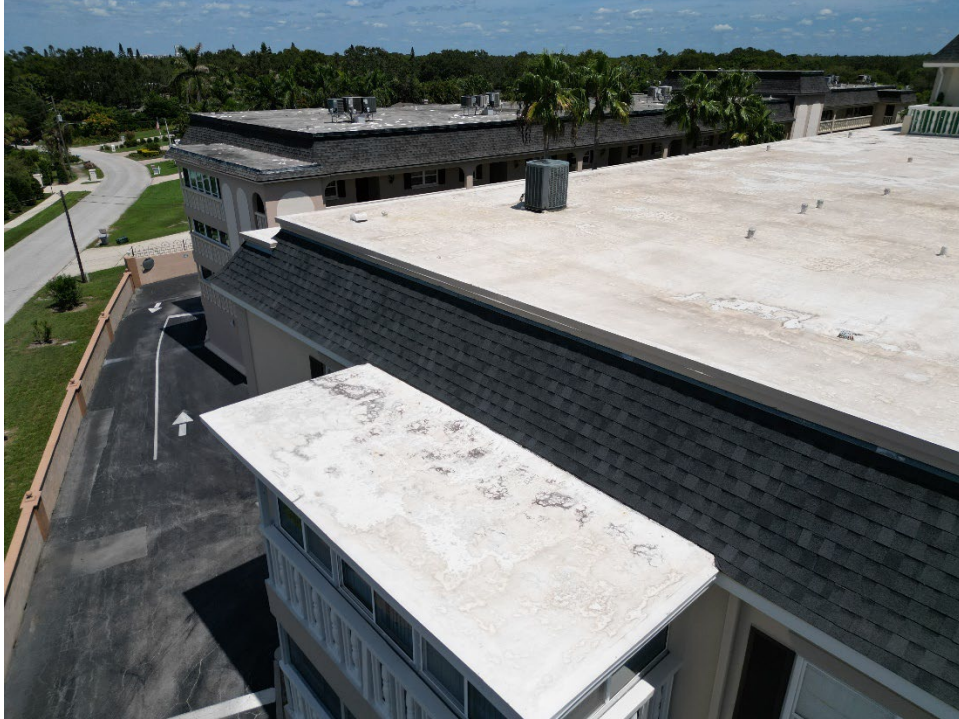
11. An example of significant deterioration on the TPO roof is the west flat roof.

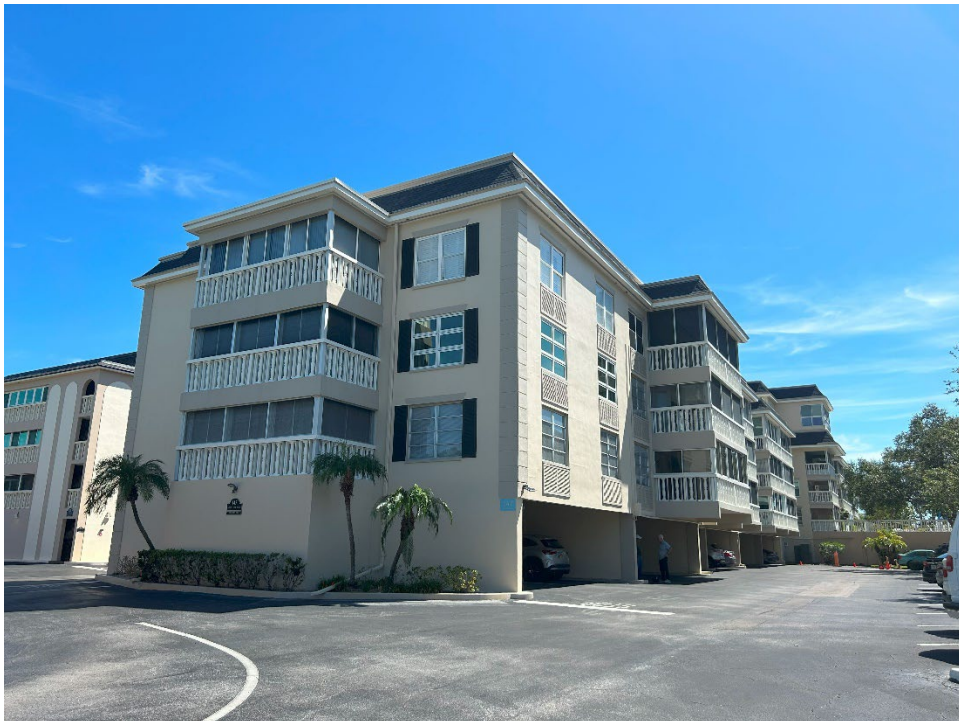
12. View of the west elevation of the building.

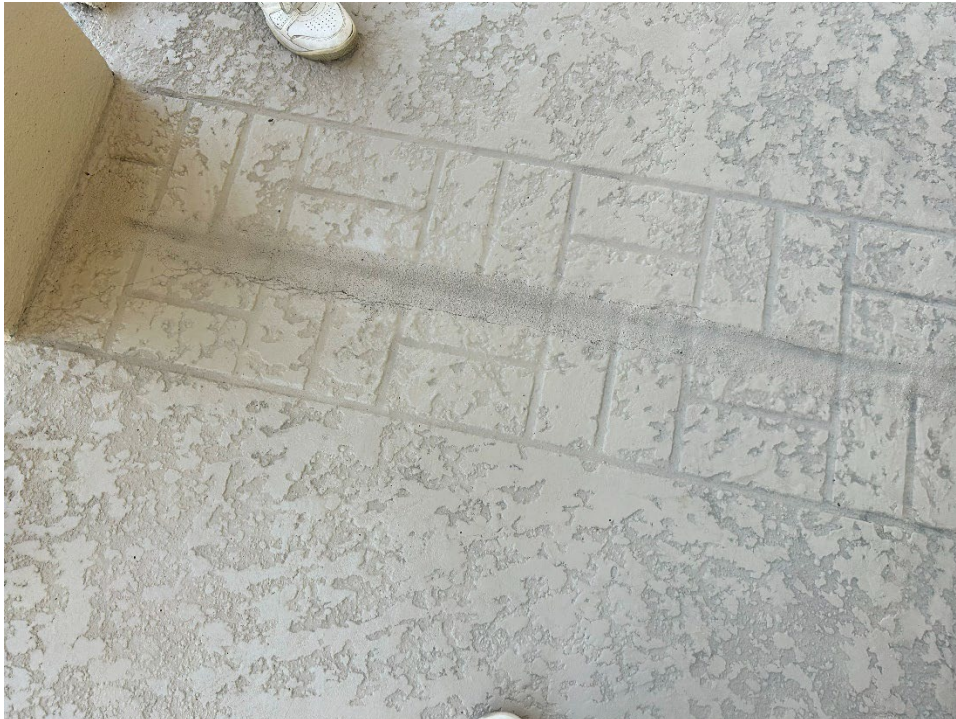
16. Cracks are occurring at the control joints in the breezeways, due to the age and design of the joints.

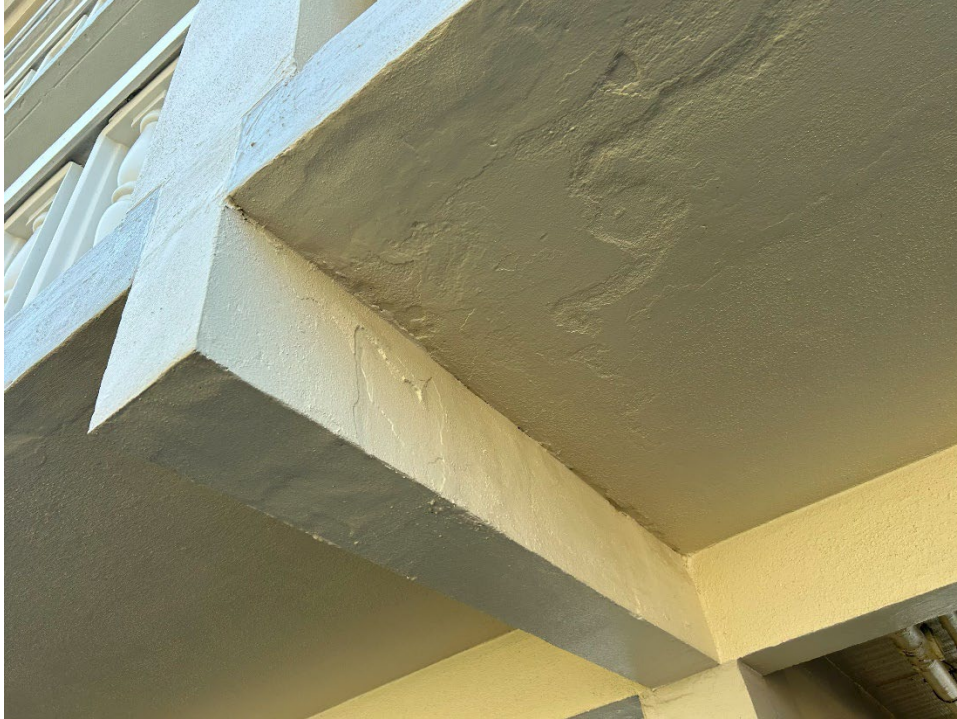
17. Delaminated portions of the stucco were painted over and not repaired properly on the underside of the second floor towards the west end of the north side of the building.

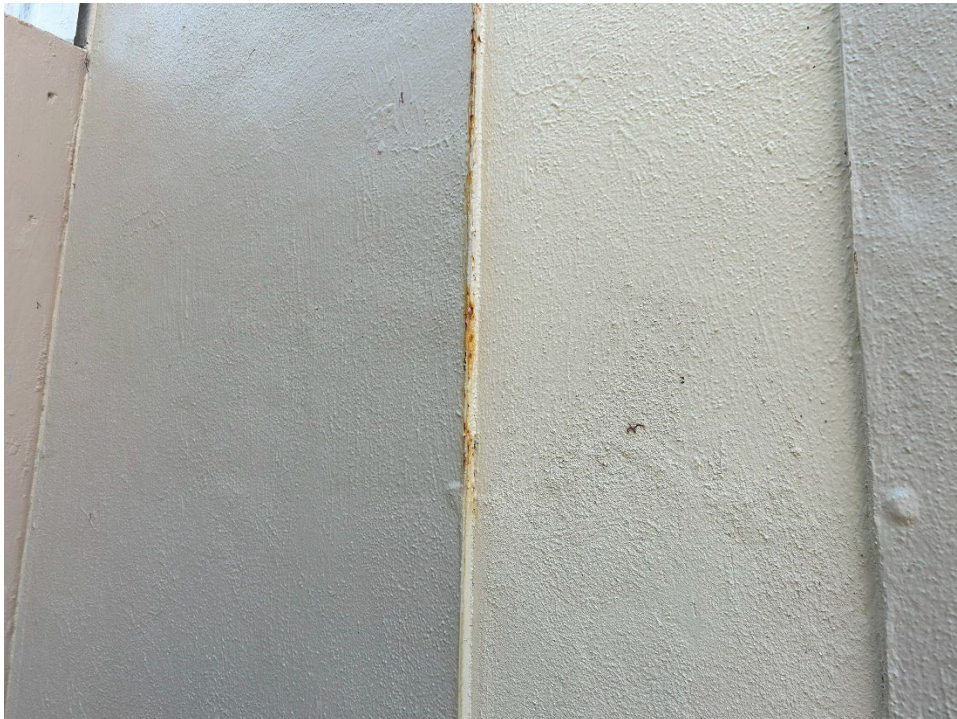
18. Corrosion from what is suspected to be the lath that the stucco is attached to indicates evidence of water infiltration into the stucco system.

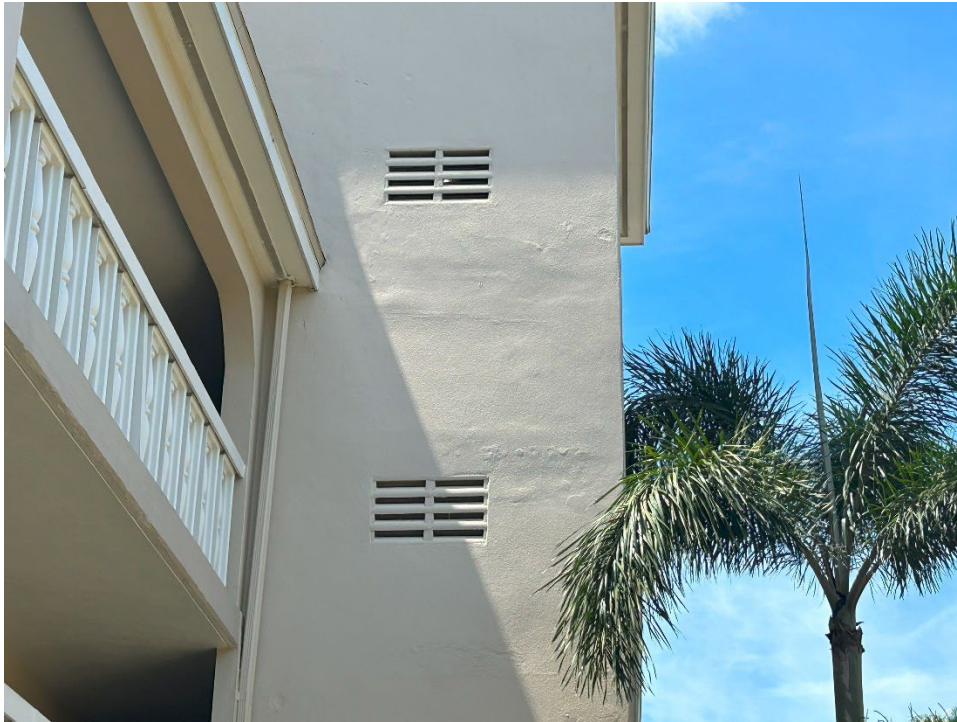
19. Example of stucco EFIs with no control joints which is resulting in cracking.

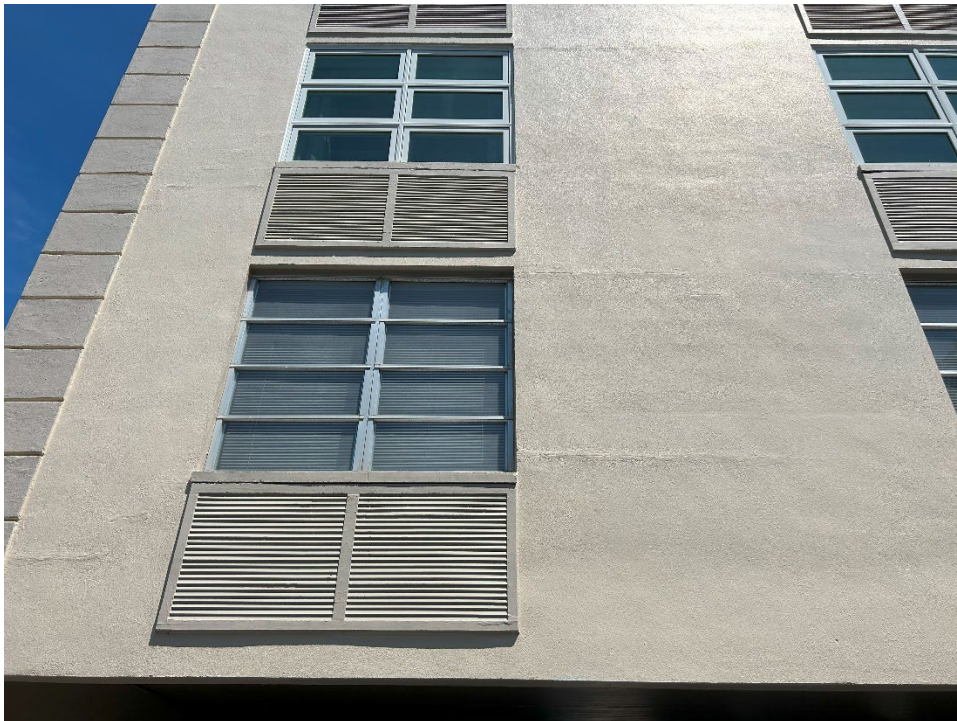
20. Stairstep cracks are located on the exterior of the building at Units 110, 210, and 310. These horizontal joints and stairstep cracks should be exposed for a Phase 2 investigation.

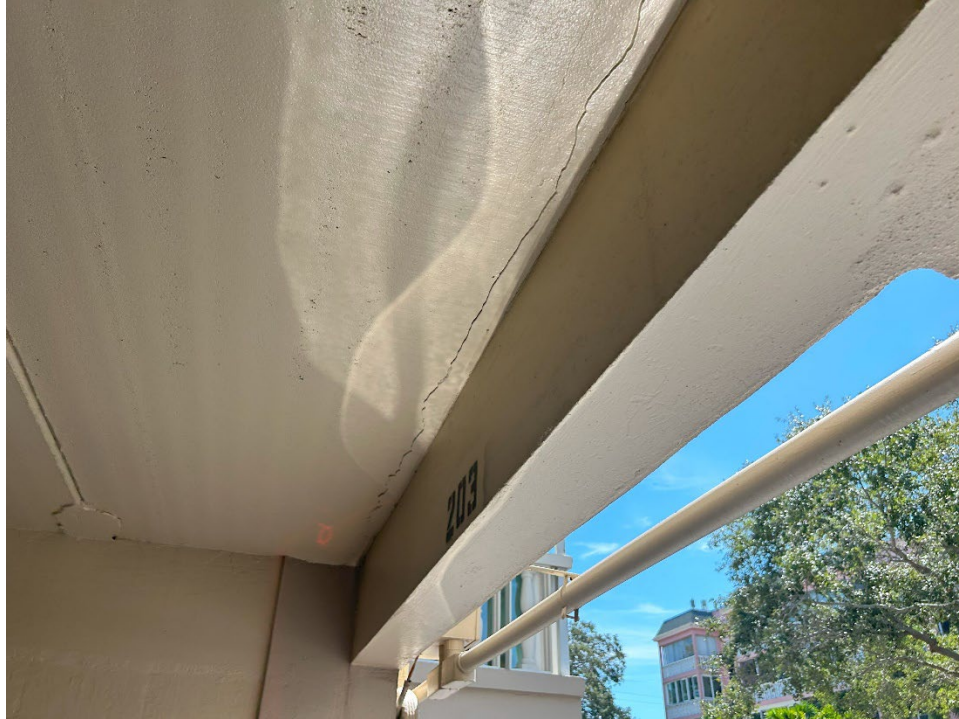
21. The poor construction method and formwork placement have resulted in a crack at the joint along the beam; however, this is not a structural concern at this time.

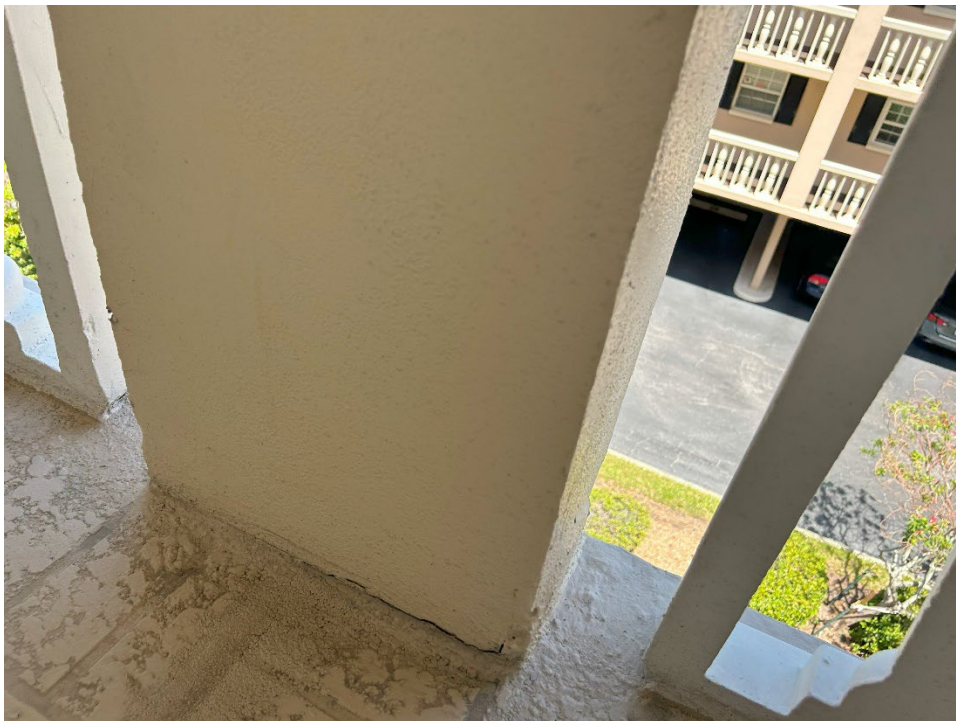
22. Joint sealant along the bottom of a column between 305 and 306 is opened and needs to be repaired.

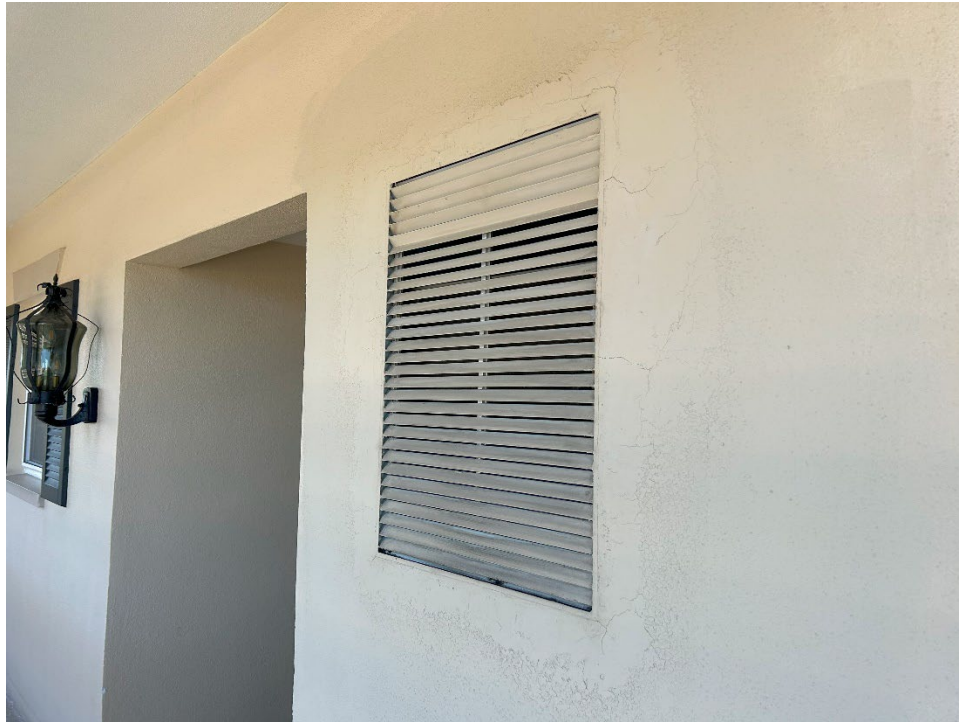
23. The patch around the HVAC unit at 308 was improperly done and should be remediated to prevent water from infiltrating into the building.

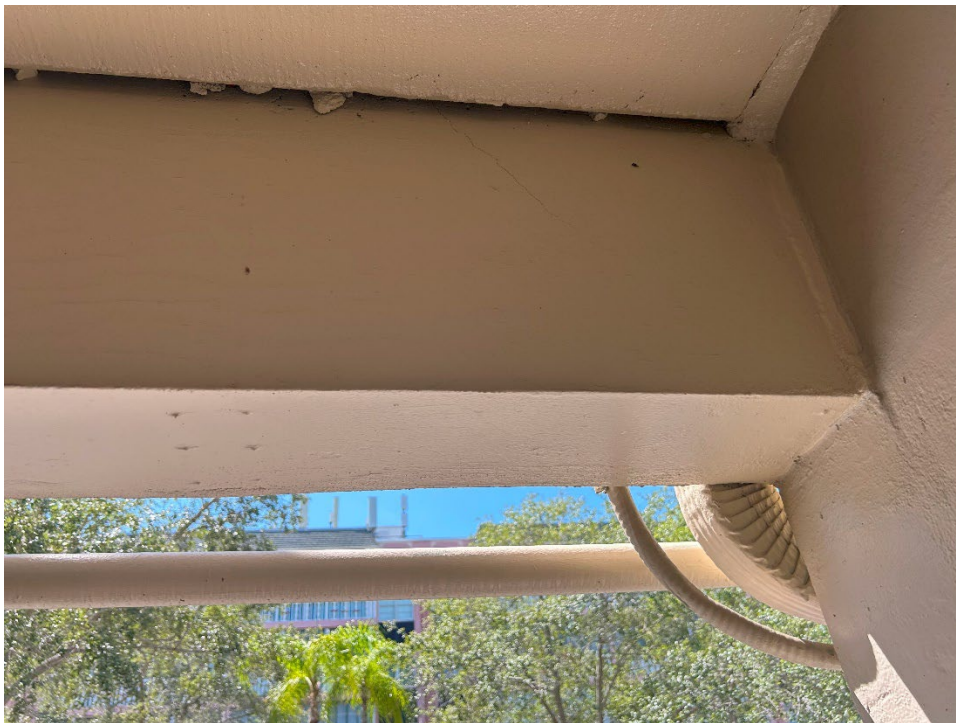
24. A shear crack developing in the beam located above parking spot 310, should have the stucco removed for a Phase 2 inspection.

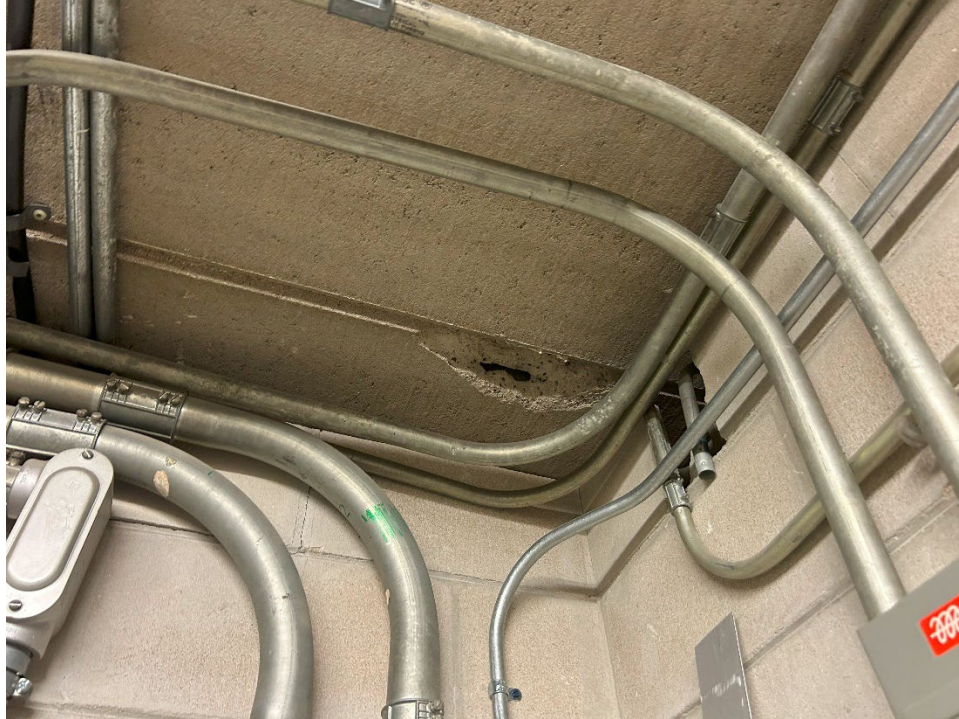
25. Spalled concrete in the electrical room is exposing rebar to the elements. This rebar should be exposed to confirm how much corrosion is present in a Phase 2 investigation.

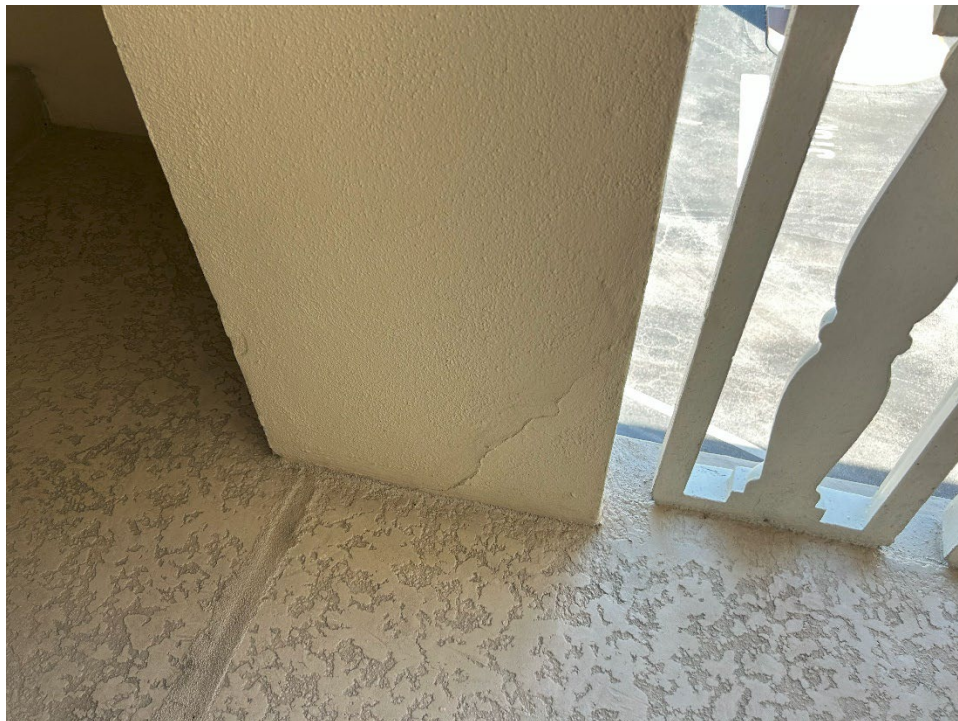
26. A shear crack is located in the column by the stairwell in front of Unit 210. The stucco should be removed for further investigation in Phase 2.

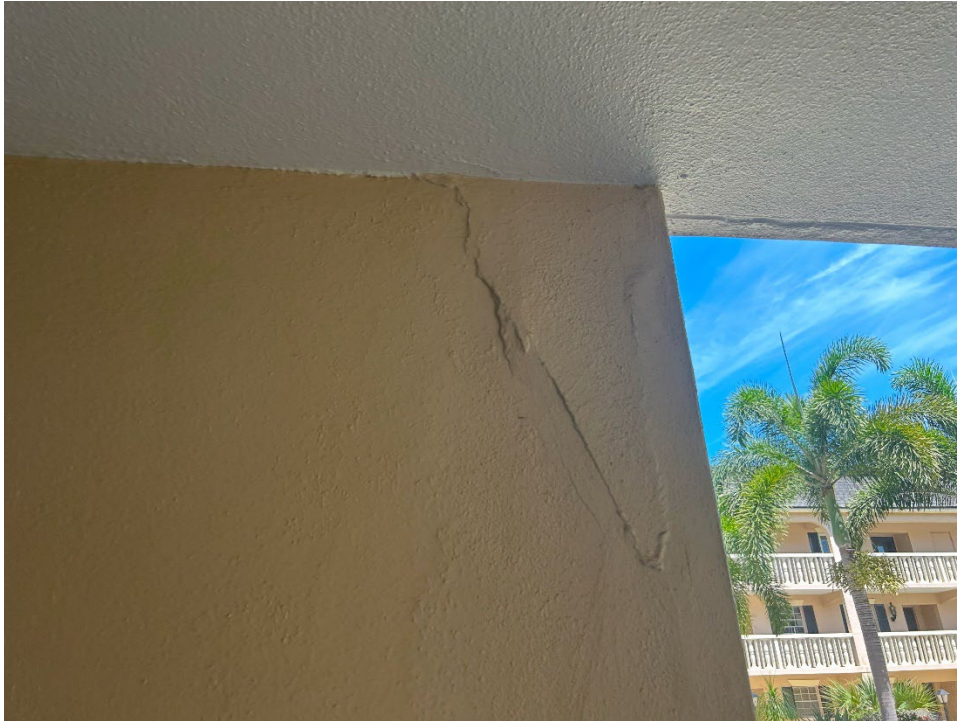
27. A shear crack is located in the column by the stairwell in front of Unit 104. The stucco should be removed for further investigation in Phase 2.

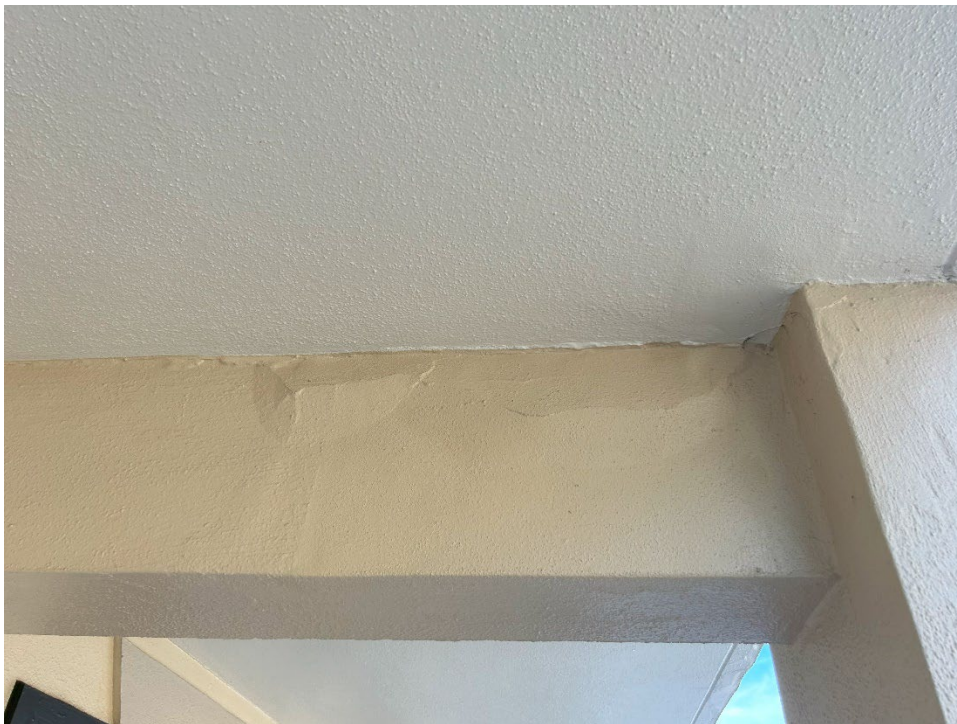
28. Evidence of an old patch or possible water infiltration at the beam in the breezeway between Units 107 and 106. This should be opened up in the Phase 2 investigation.

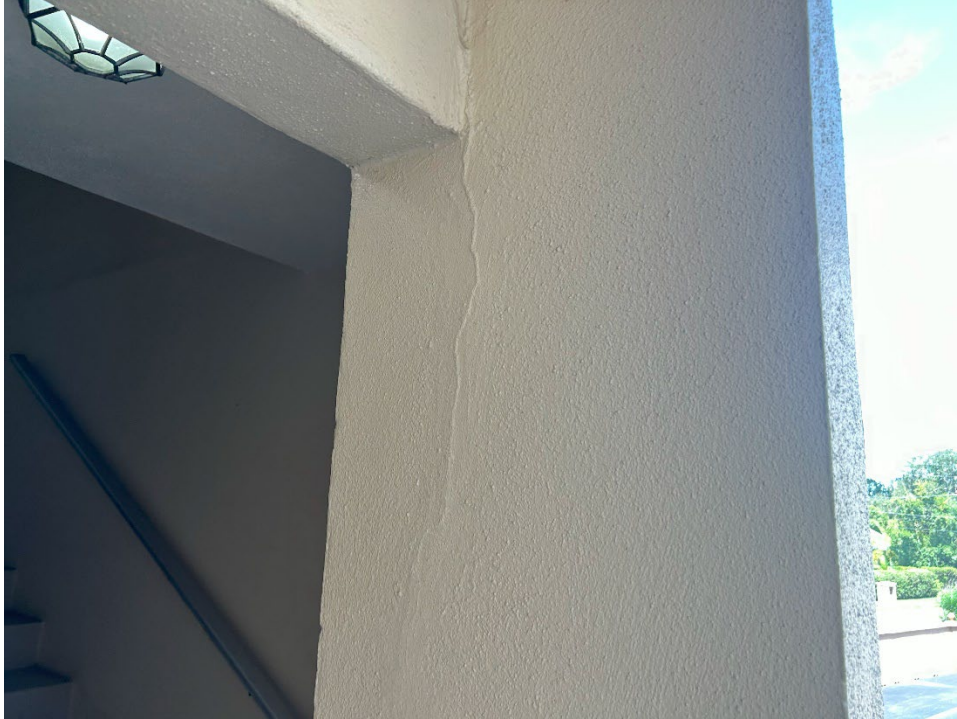
29. The shear crack propagating from the beam in front of Unit 110 should be exposed in a Phase 2 investigation.

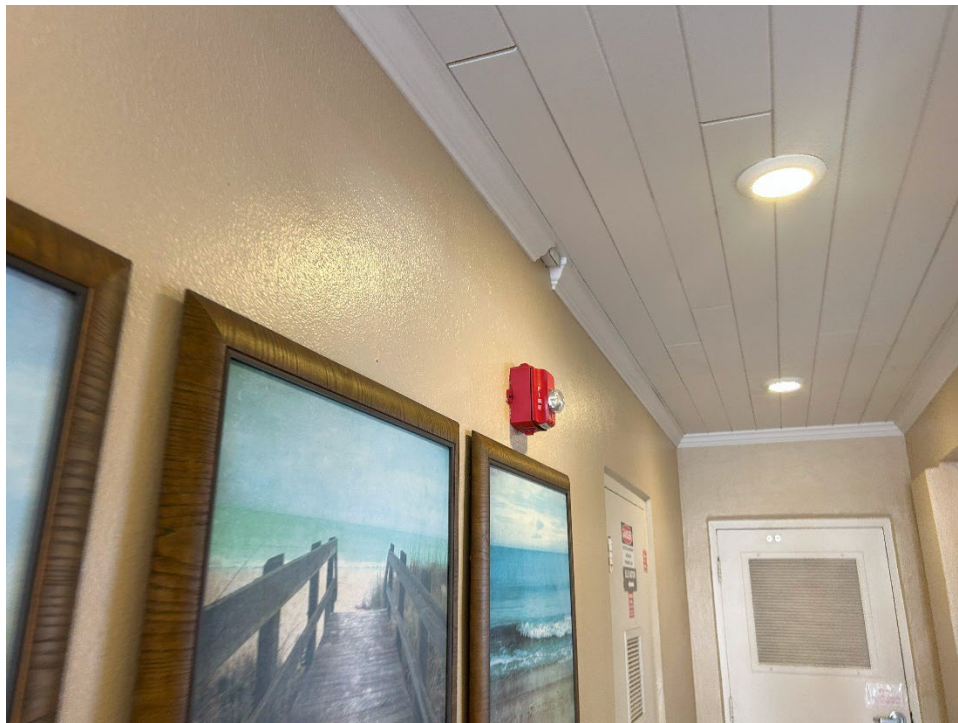
30. Typical example of fire safety equipment.
