## Windstorm Mitigation Report

Port Belleair No. 2, Inc., A Condominium

As of 05-19-2025 | FPAT File# MUD2524753

147 Bluff View Dr, Units 101-402

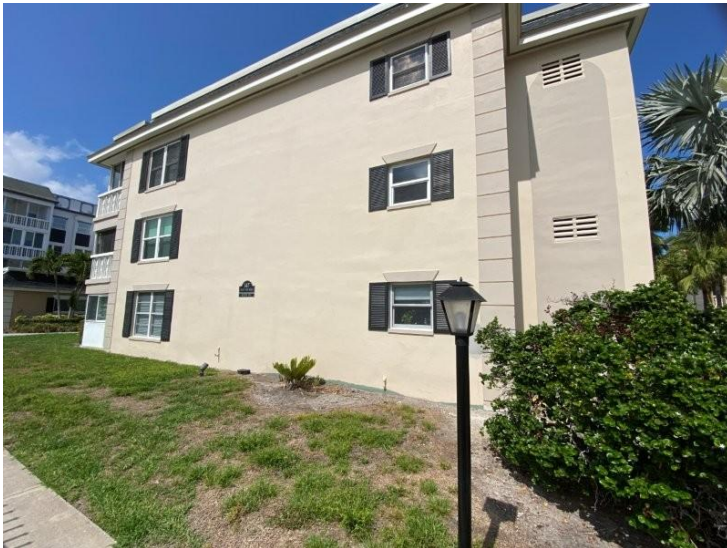
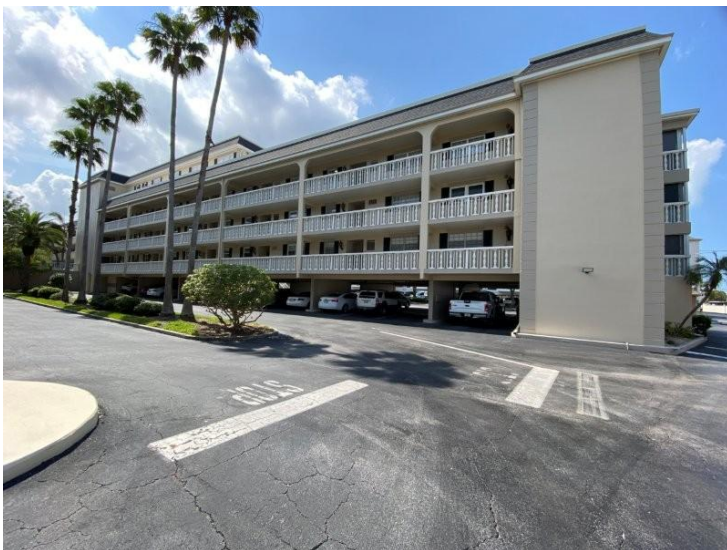
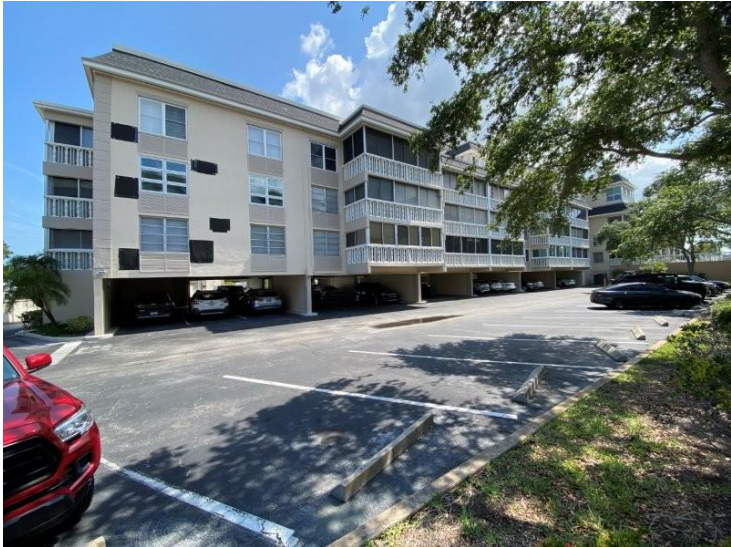
Exterior Elevation

| <b>5. Roof Geometry:</b><br>Comments: | <b>Flat Roof</b><br>Inspection verified flat roof shape, refer to attached photographs. |
| <b>7. Opening Protection:</b><br>Comments: | <b>None or Some Glazed Openings</b><br>No opening protection verified at the time of inspection. |

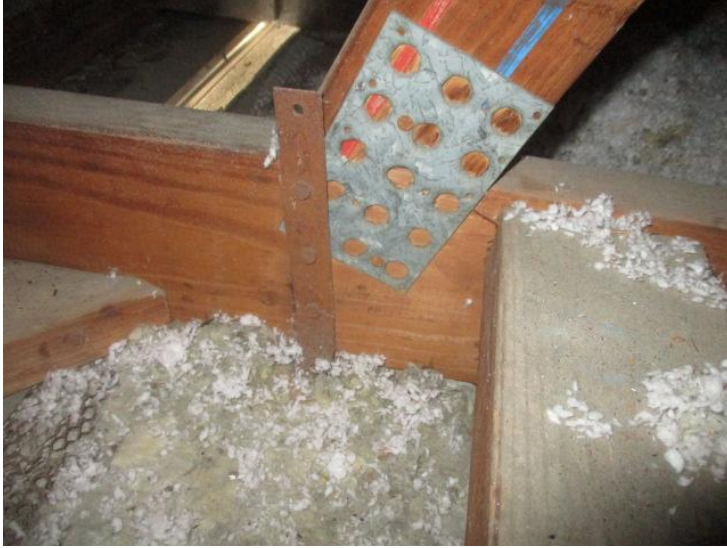
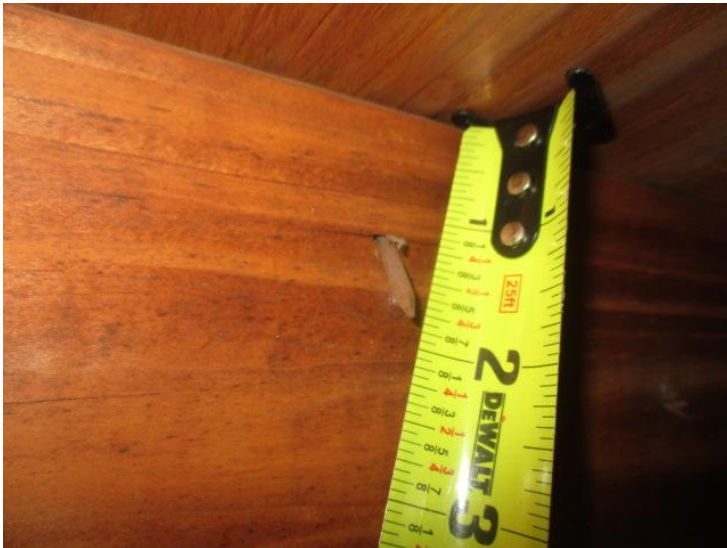
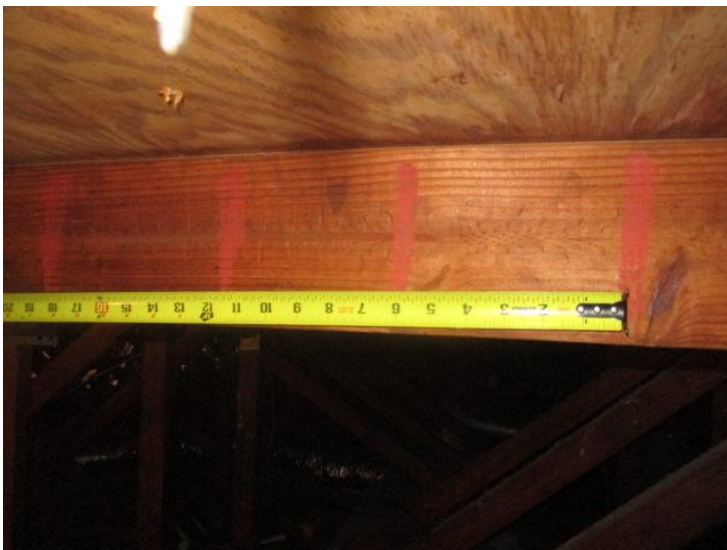
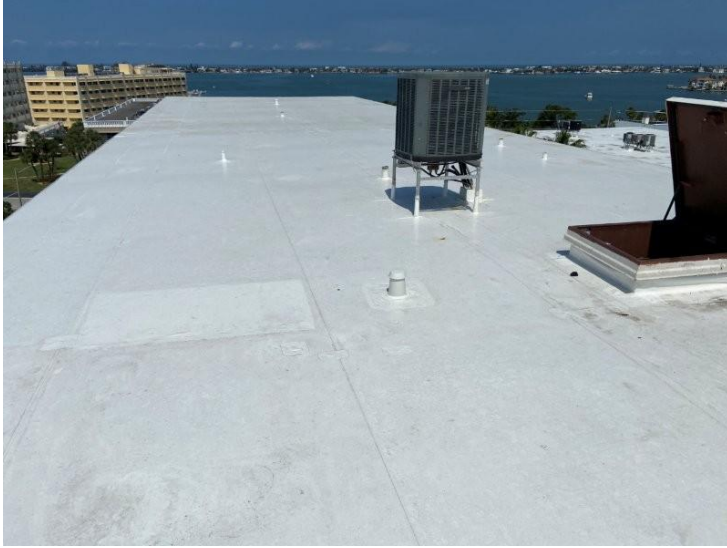
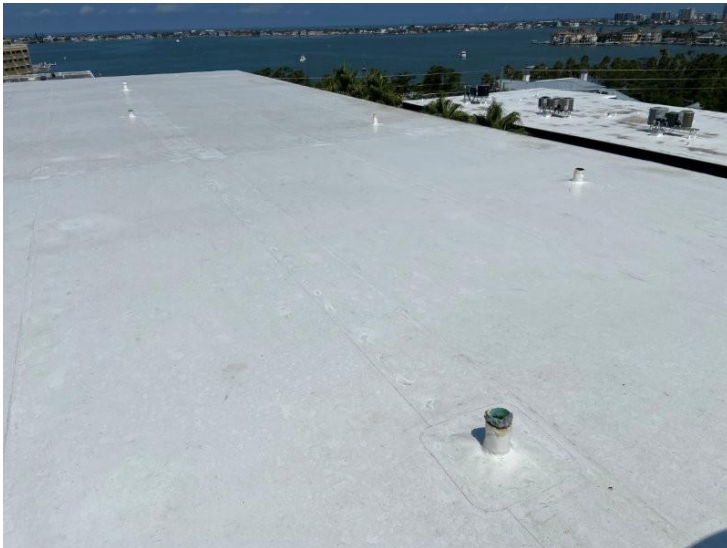
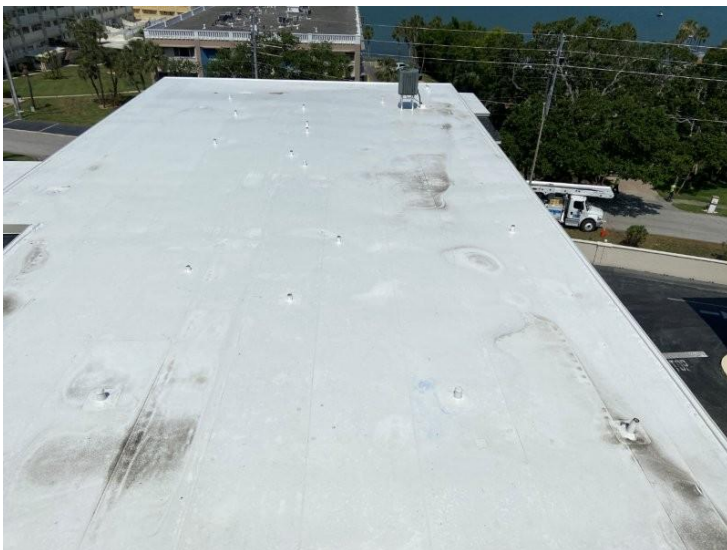
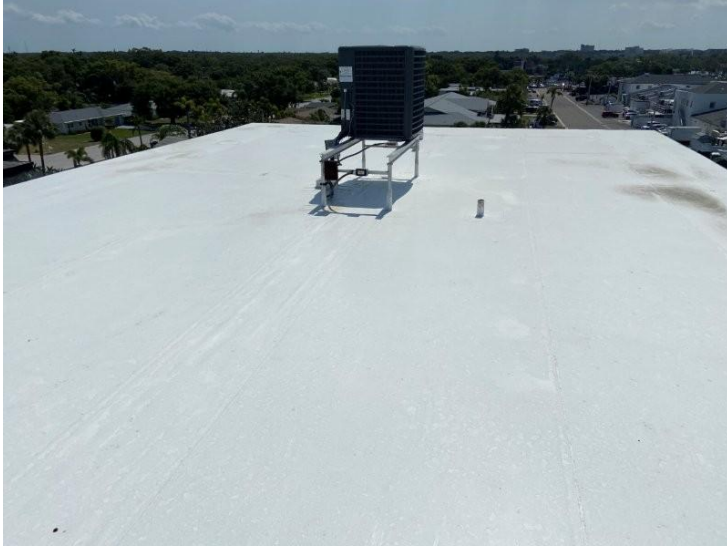
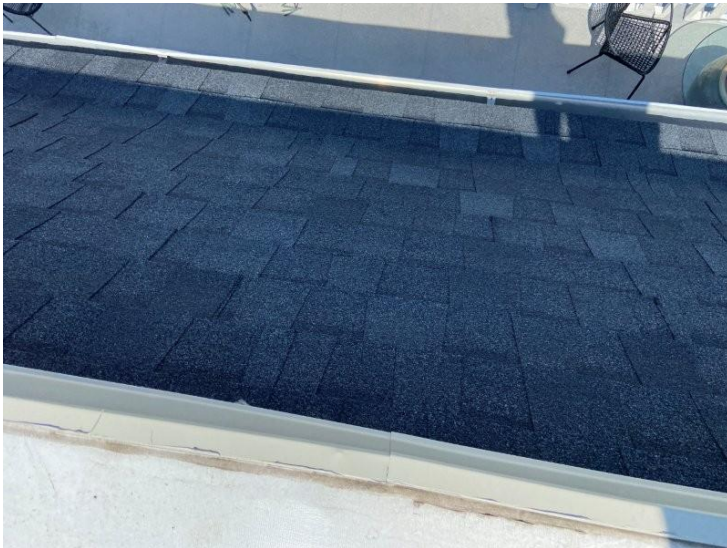
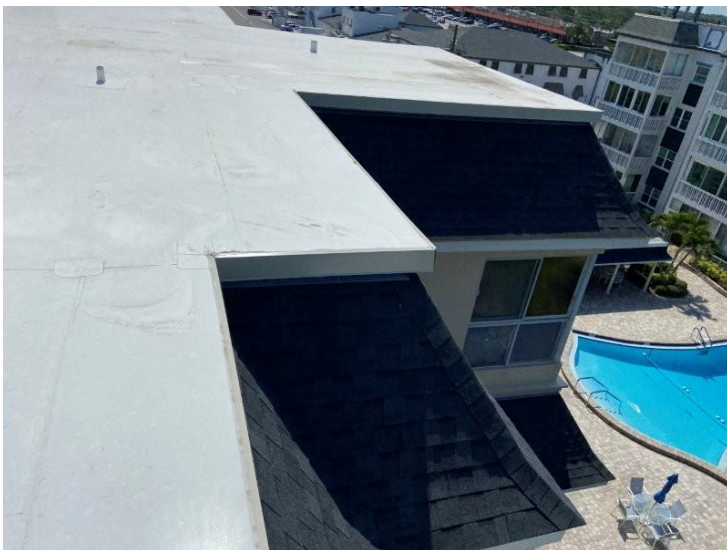
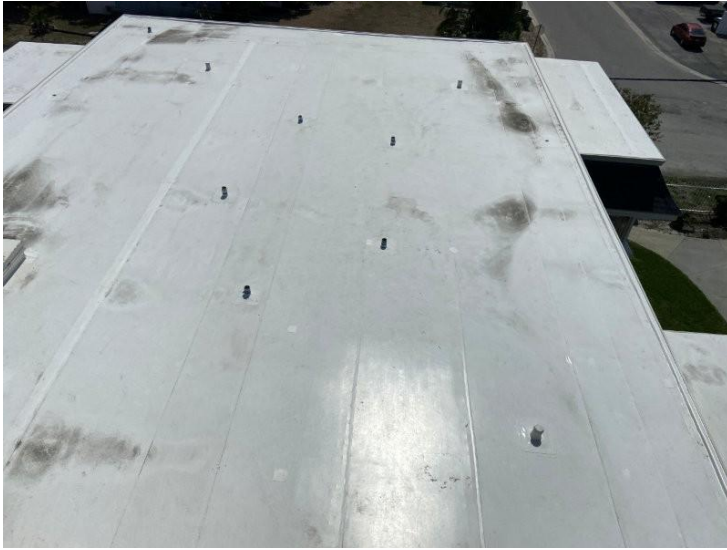
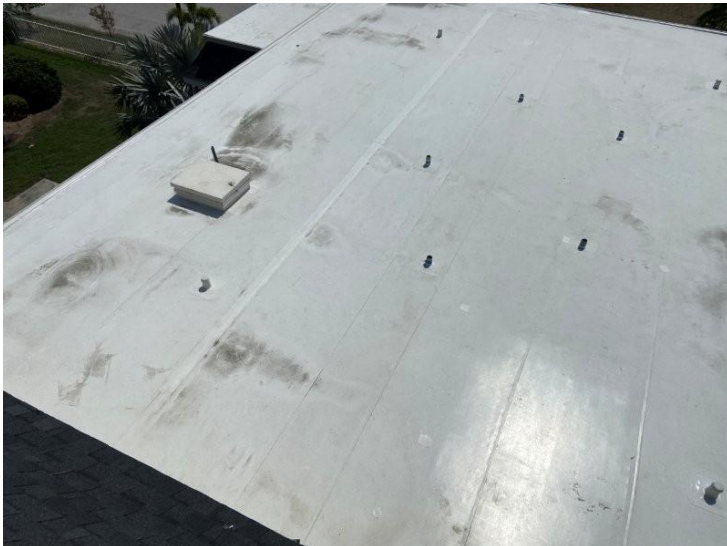
Roof Construction

| <b>3. Roof Deck Attachment:</b><br>Comments: | <b>Level C</b><br>Inspection verified 1/2" plywood roof deck attached with 8d nails at a minimum 6" on the edge & 6" in the field. |
| <b>4. Roof to Wall Attachment:</b><br>Comments: | <b>Clips</b><br>Inspection verified embedded straps fastened with a minimum of three nails. |
| <b>6. SWR:</b><br>Comments: | <b>No</b><br>No SWR verified. |

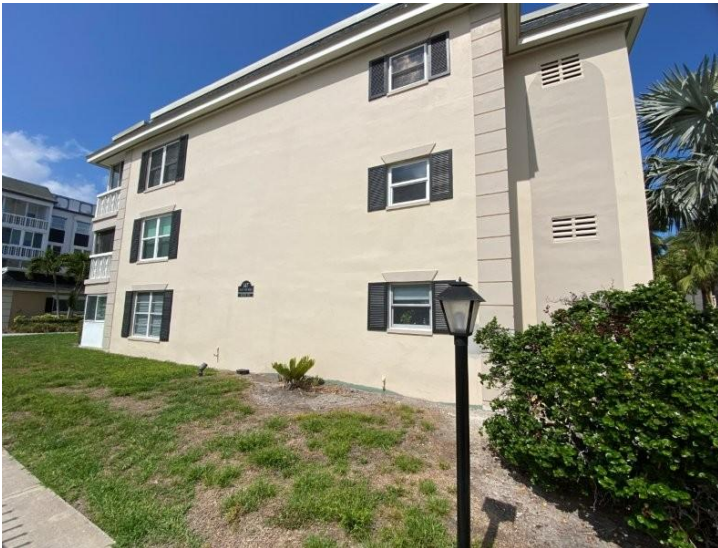
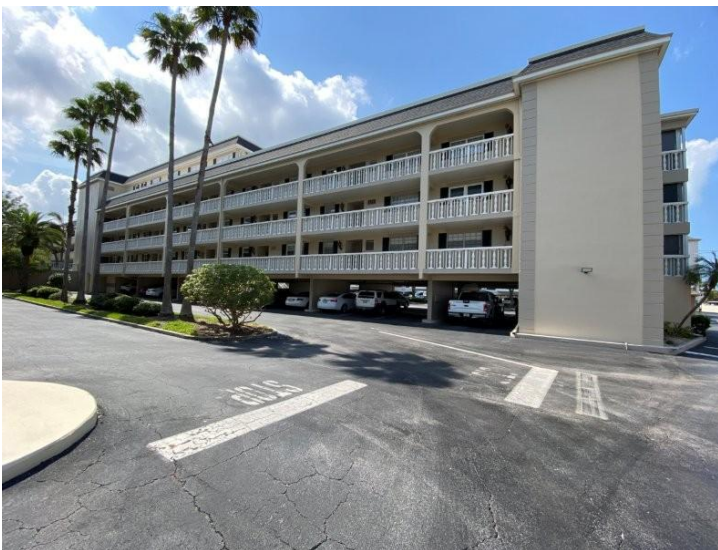
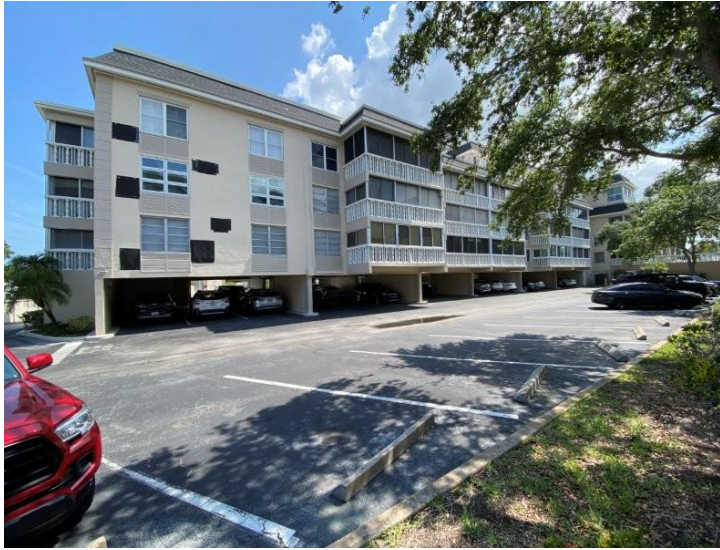
Exterior Elevation

| <b>4. Opening Protection:</b><br>Comments: | <b>None or Some Glazed Openings</b><br>No opening protection verified at the time of inspection. |

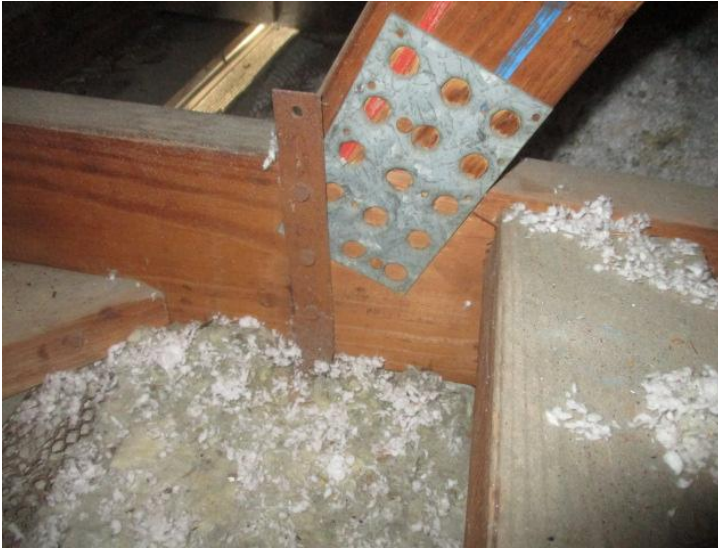
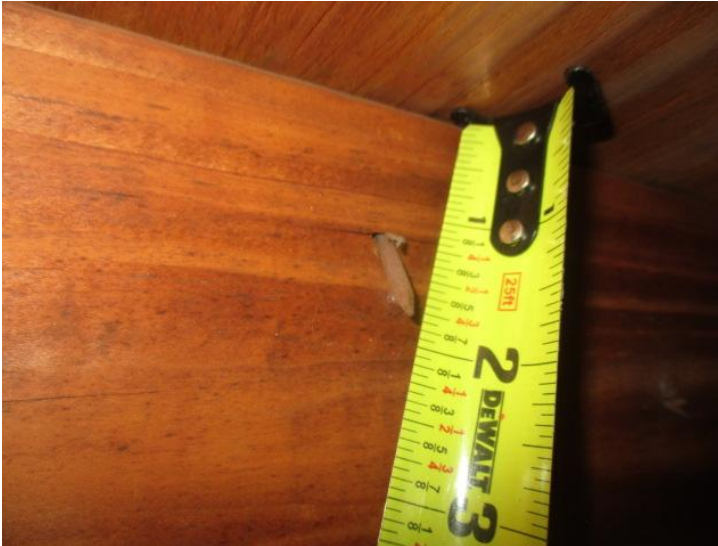
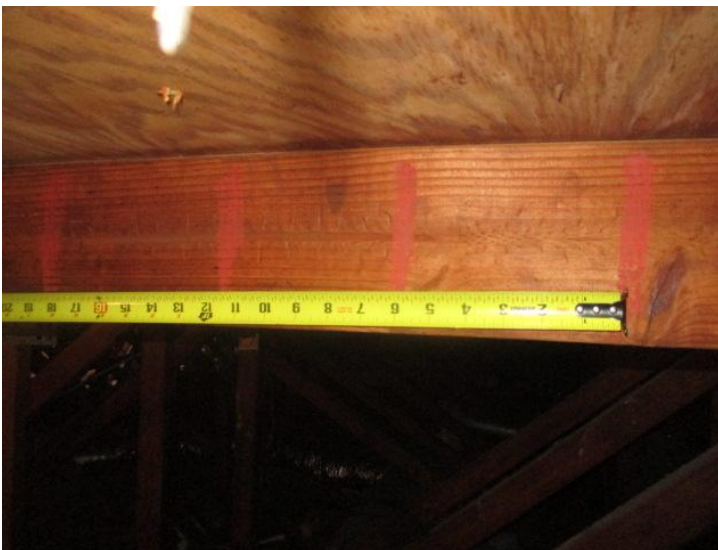
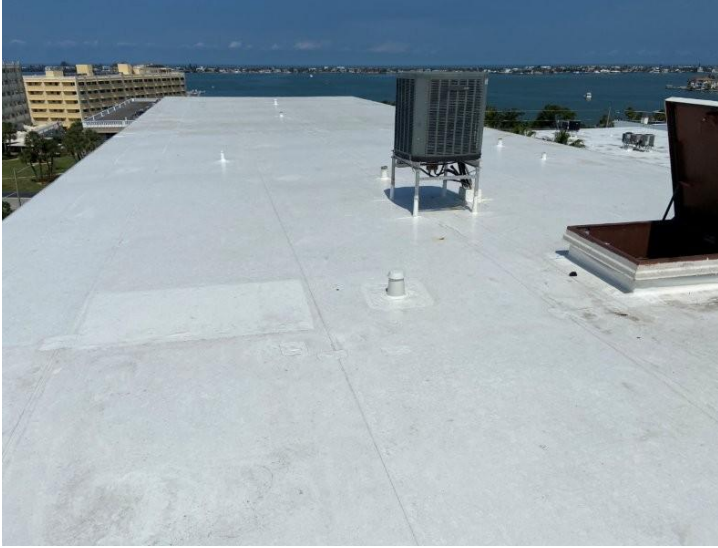
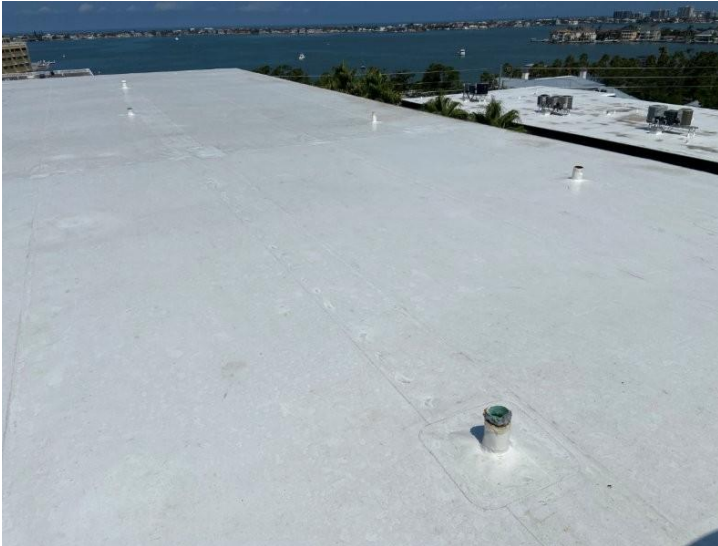
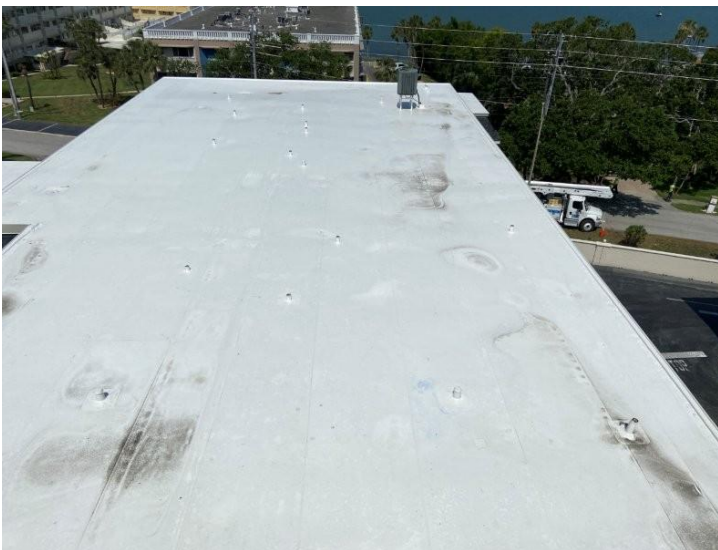
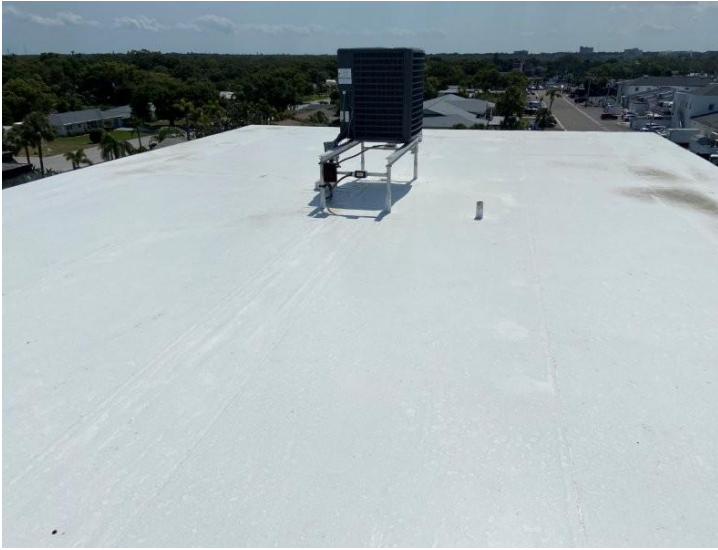
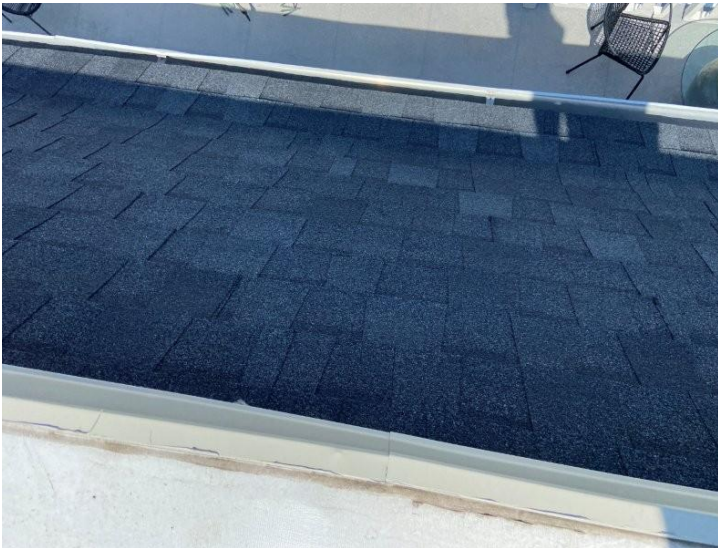
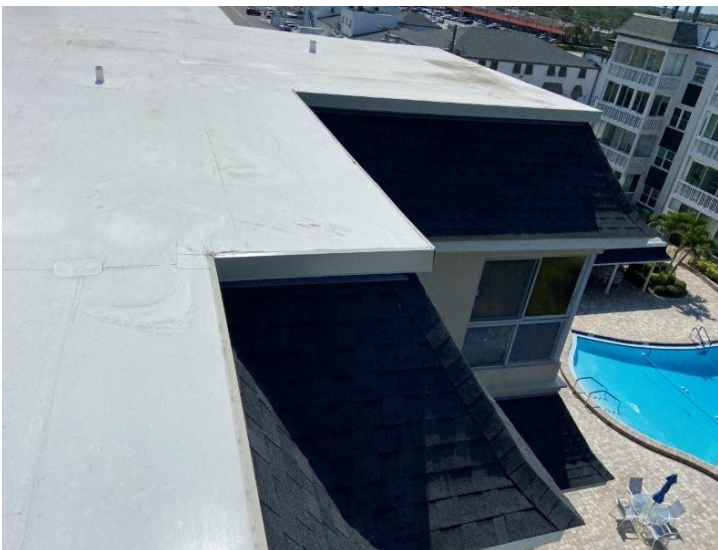
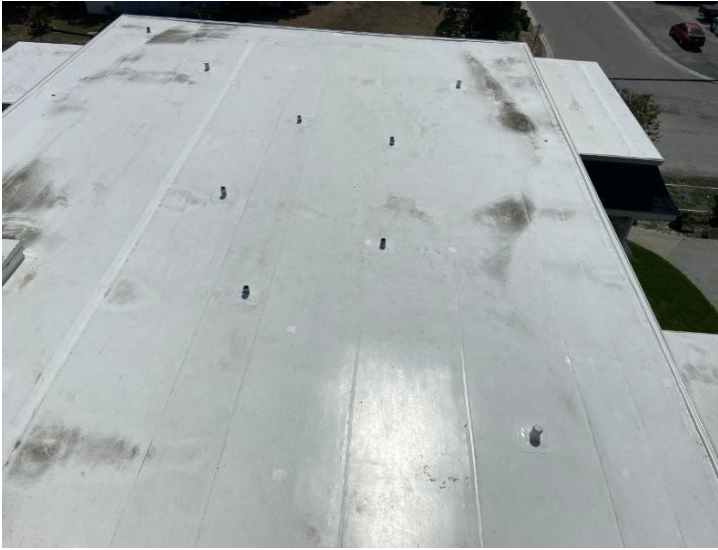
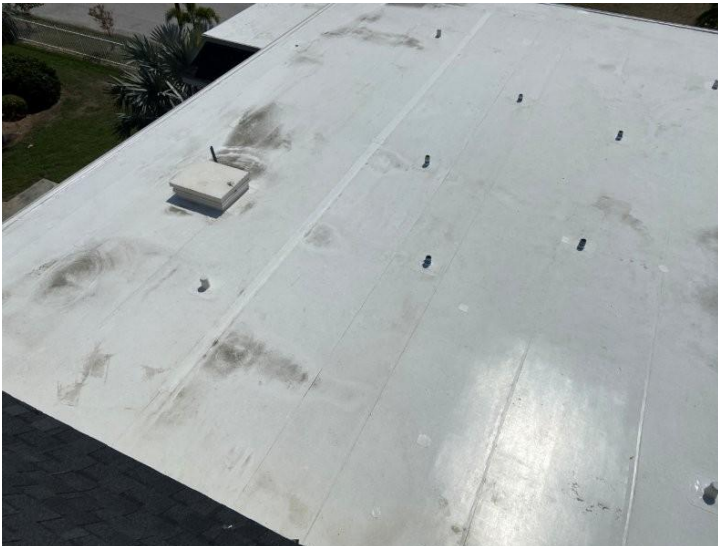
Roof Construction

| <b>1. Roof Covering:</b><br>Comments: | <b>FBC Equivalent</b><br>The flat roof was replaced in 2024. The roof permit was confirmed and the permit number is EBP-24-17927. The mansard roof covering was replaced in 2022. The permit was confirmed and the permit number is EBP-22-19311. This roof was verified as meeting the building code requirements outlined on the OIR 1802 form. |
| <b>3. SWR:</b><br>Comments: | <b>No</b><br>No SWR verified. |

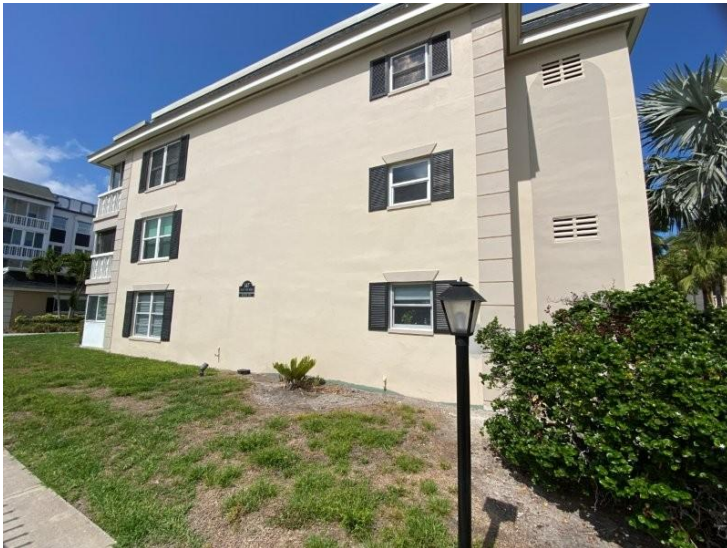
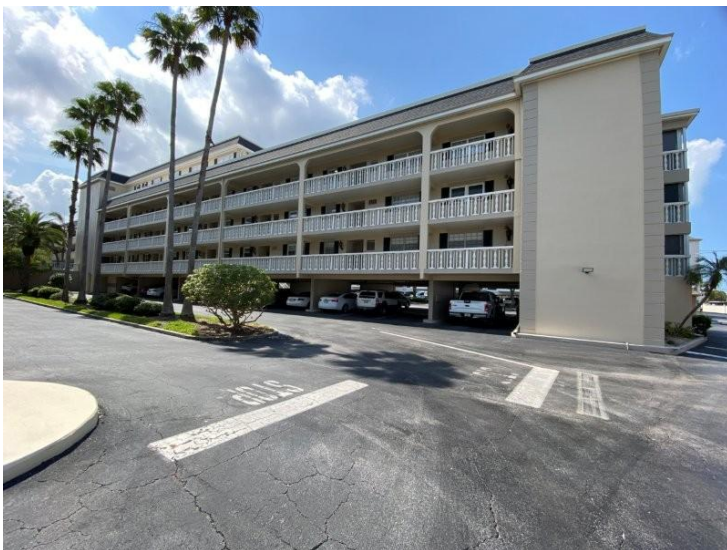
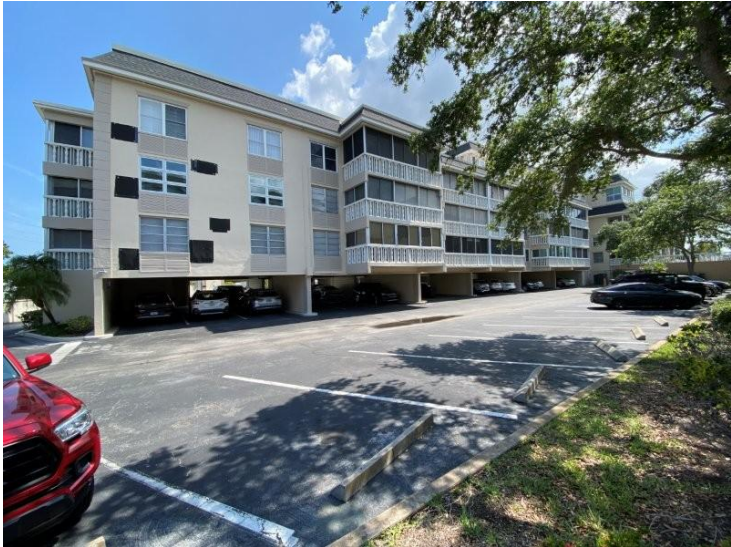
Exterior Elevation

| <b>7. Opening Protection:</b><br>Comments: | <b>None or Some Glazed Openings</b><br>No opening protection verified at the time of inspection. |

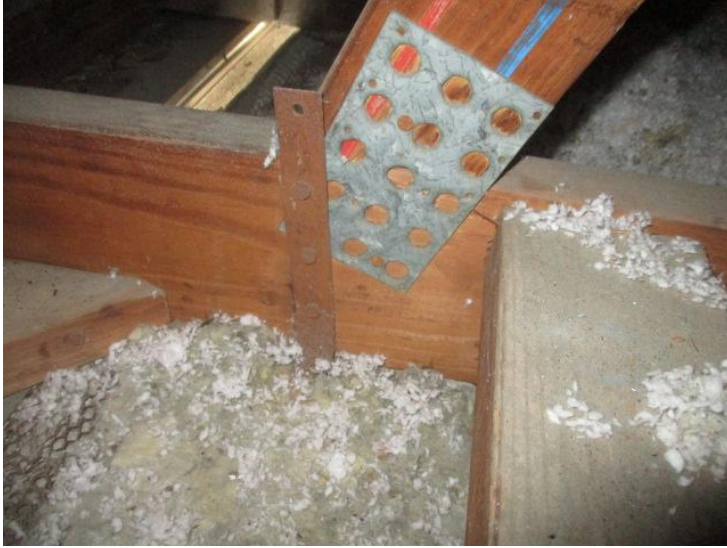
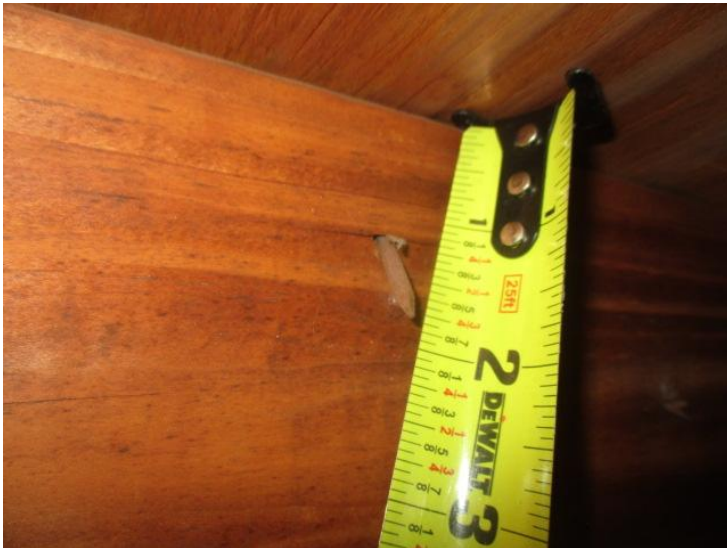
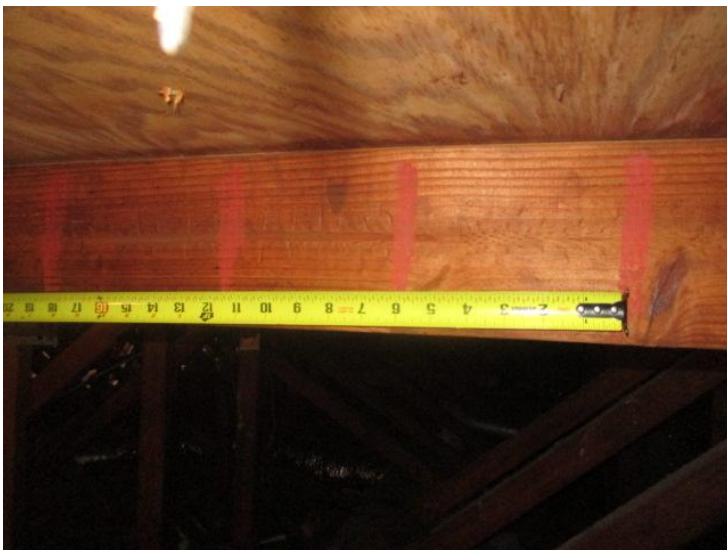
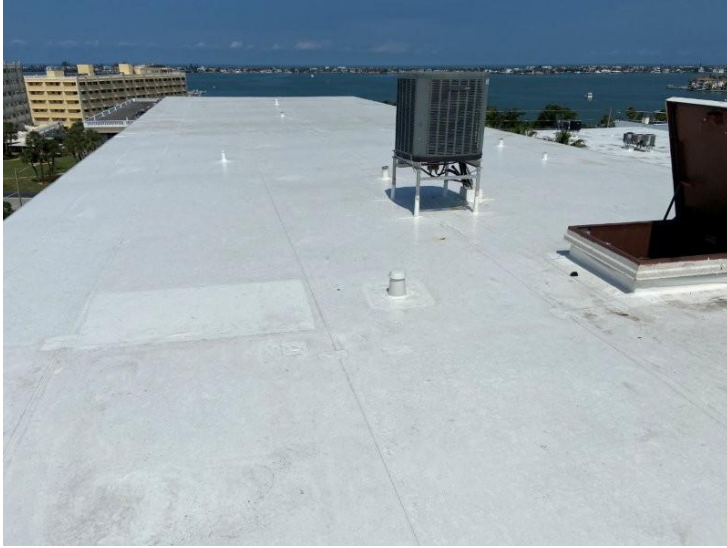
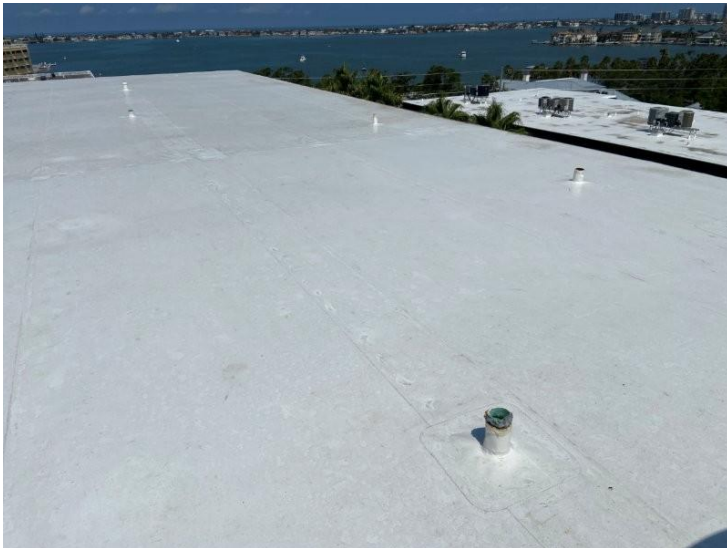
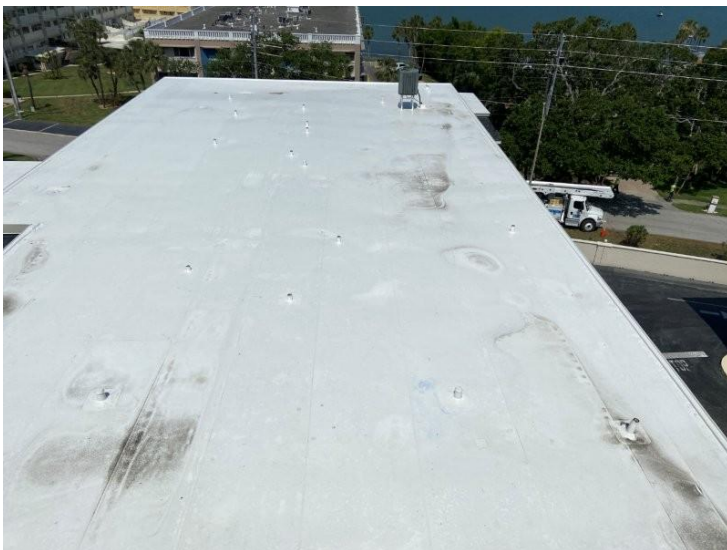
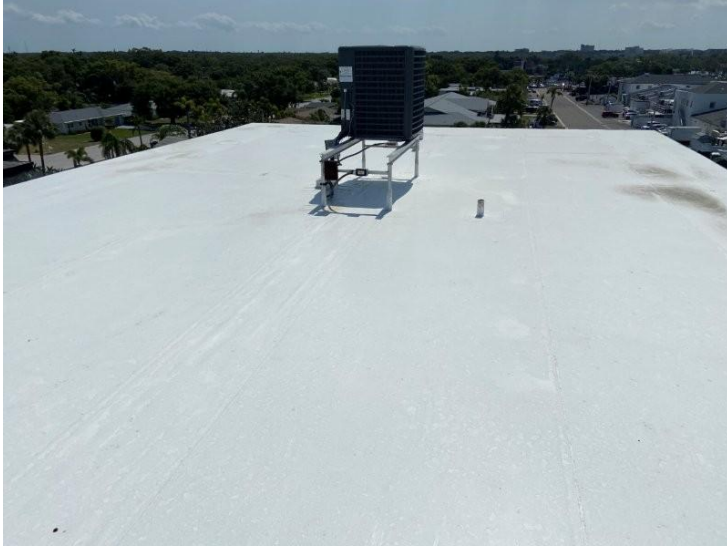
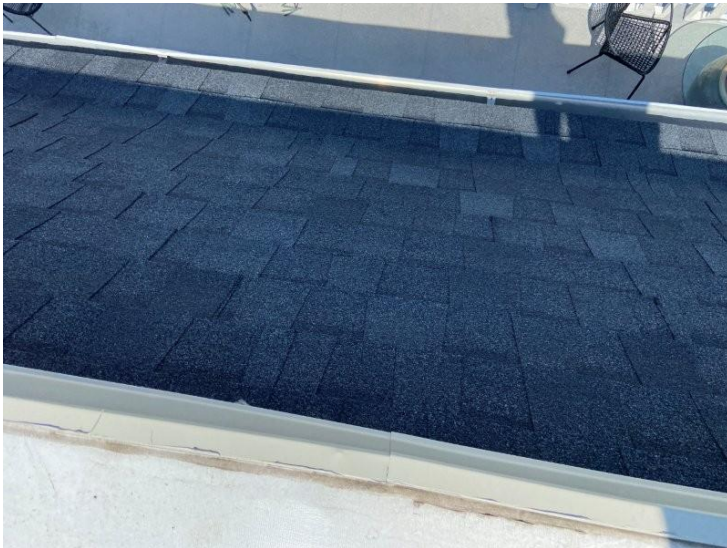
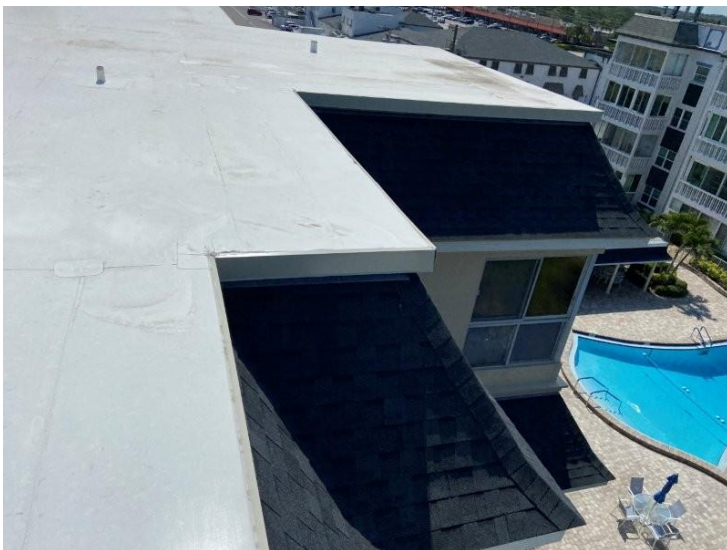
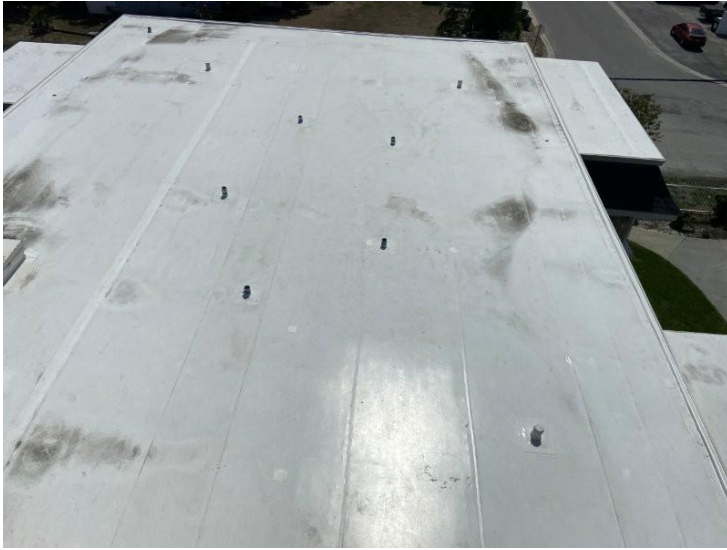
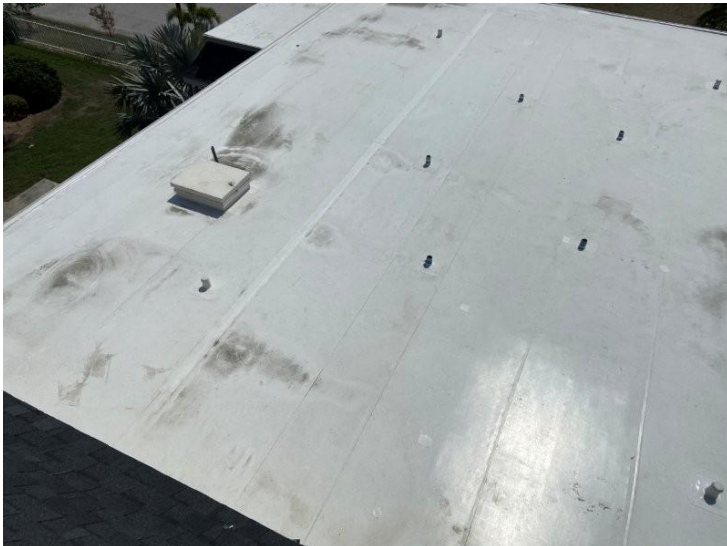
Roof Construction

| <b>2. Roof Covering:</b><br>Comments: | <b>FBC Equivalent</b><br>The flat roof was replaced in 2024. The roof permit was confirmed and the permit number is EBP-24-17927. The mansard roof covering was replaced in 2022. The permit was confirmed and the permit number is EBP-22-19311. This roof was verified as meeting the building code requirements outlined on the OIR 1802 form. |
| <b>6. SWR:</b><br>Comments: | <b>No</b><br>No SWR verified. |
