Windstorm Mitigation Report

Port Belleair No. 2, Inc., A Condominium

Belleair Bluffs, FL

Windstorm Mitigation Report (OIR-B1-1802)

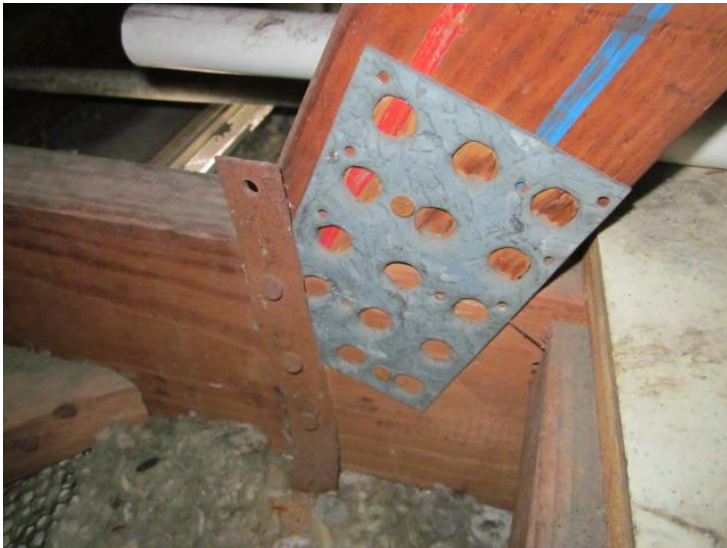
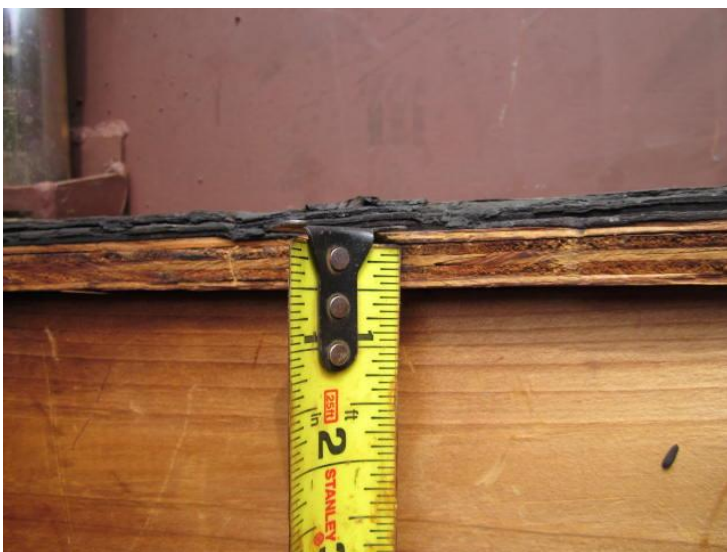
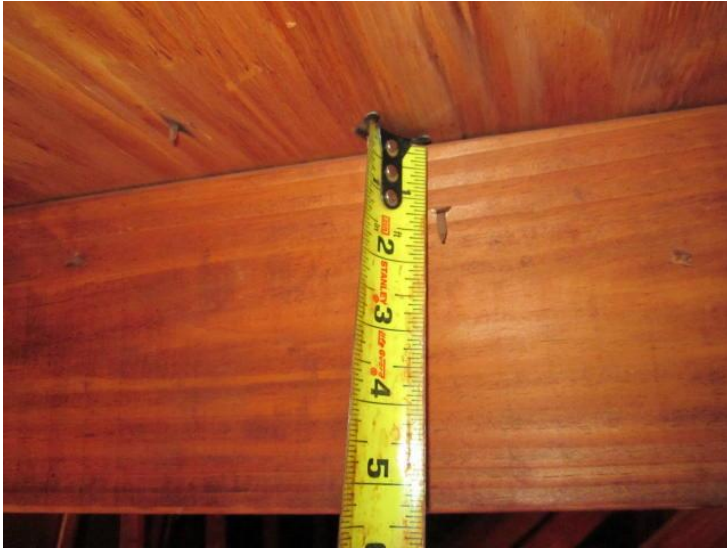
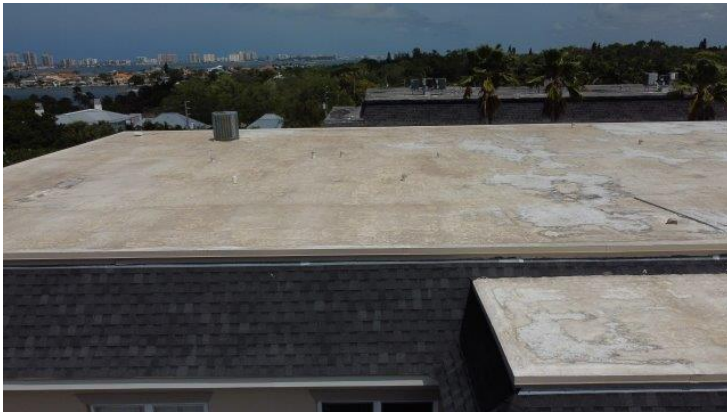
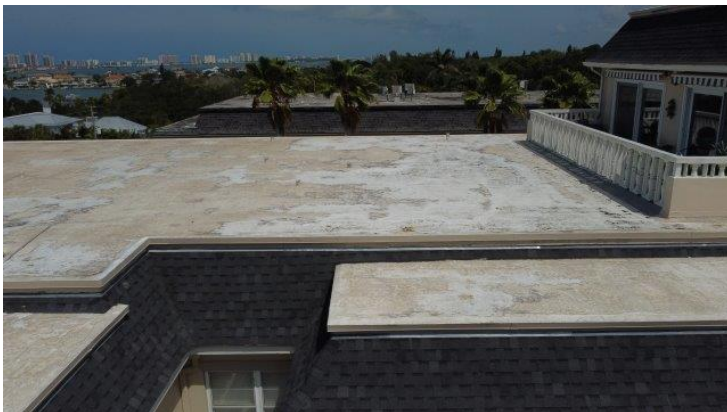
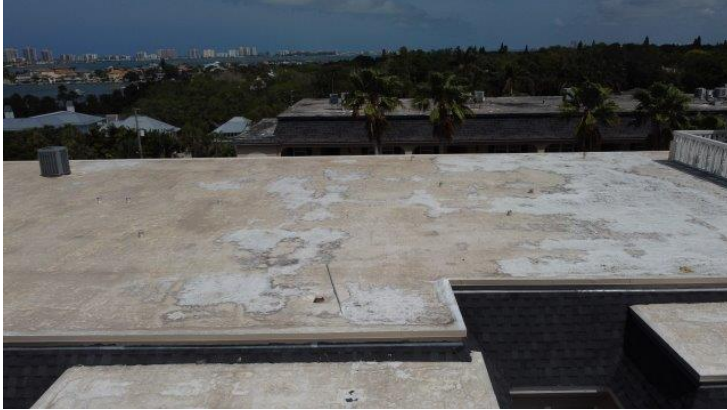
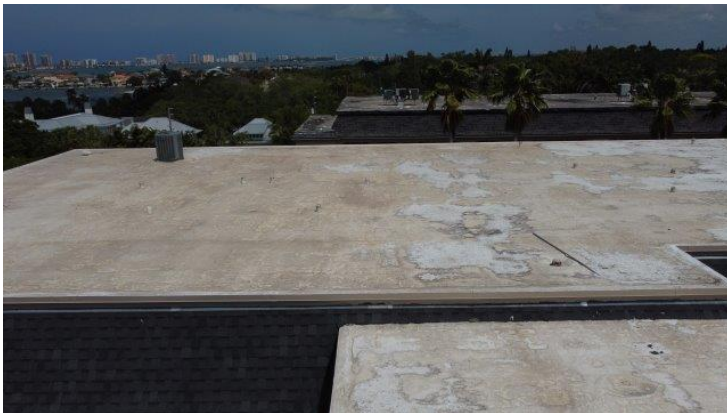
Roof Construction

- 3. Roof Deck Attachment:** **Level A**
Comments: Inspection verified 1/2" plywood roof deck attached with 6d nails at a minimum of 6" on the edge & 12" in the field.

- 4. Roof to Wall Attachment:** **Clips**
Comments: Inspection verified embedded straps fastened with a minimum of three nails.
- 5. Roof Geometry:** **Flat Roof**
Comments: Inspection verified flat roof shape, refer to attached photographs.

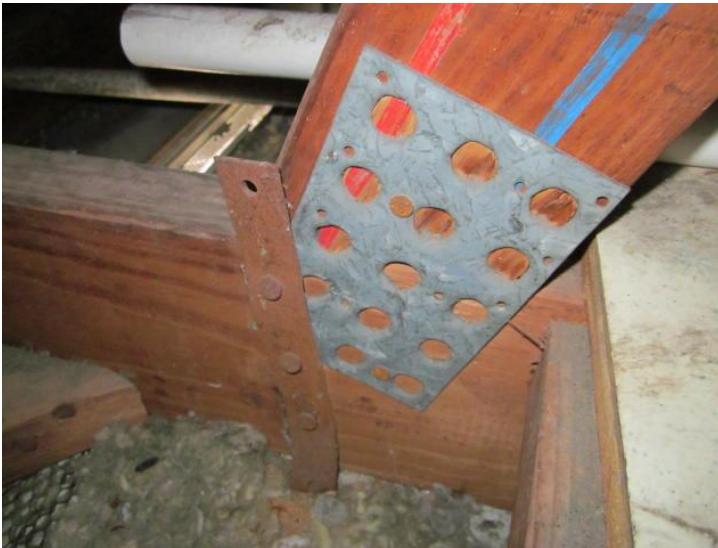
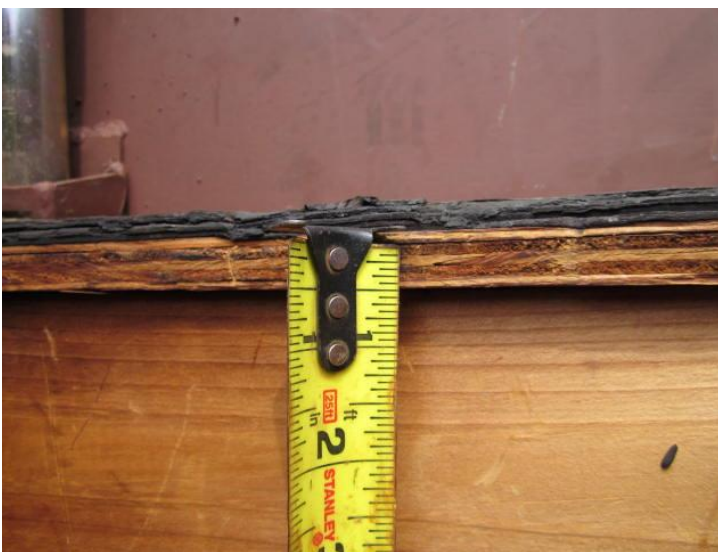
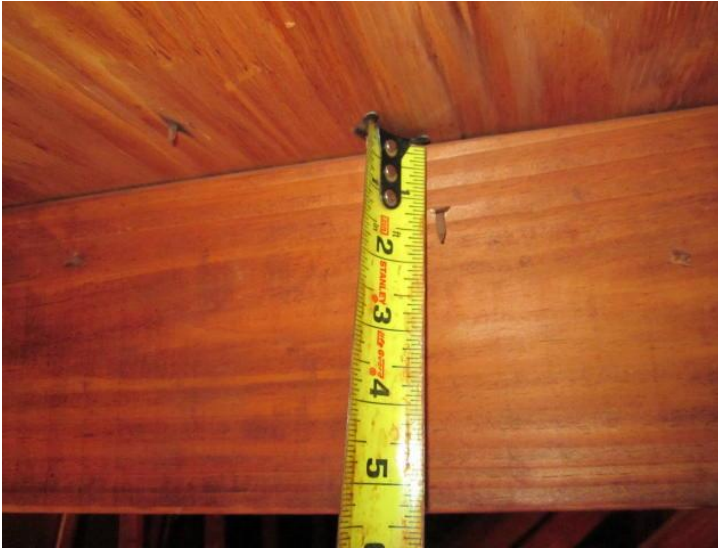
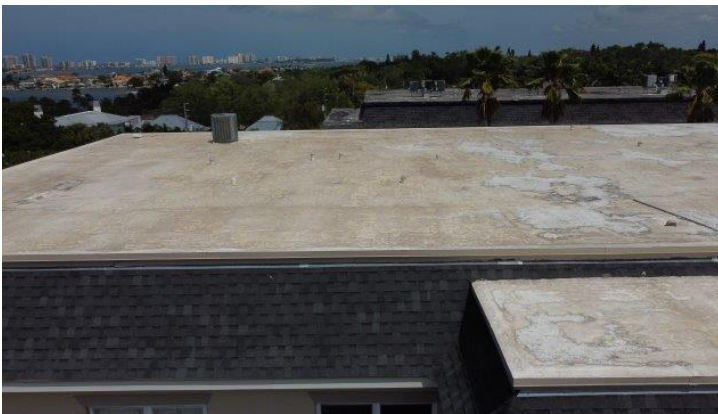
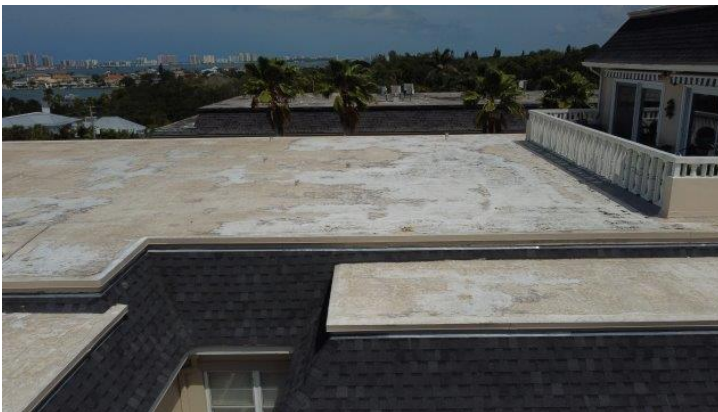
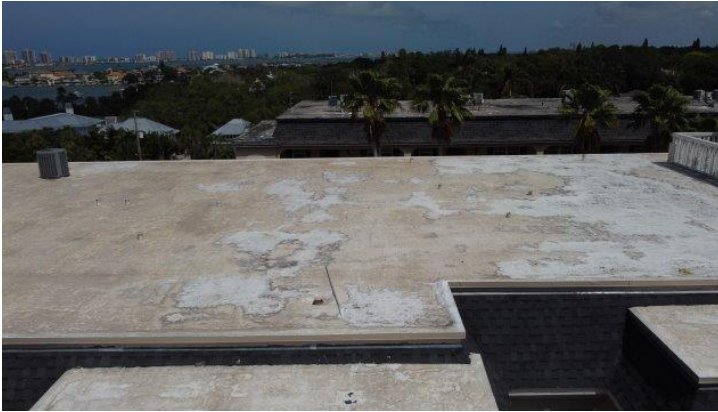
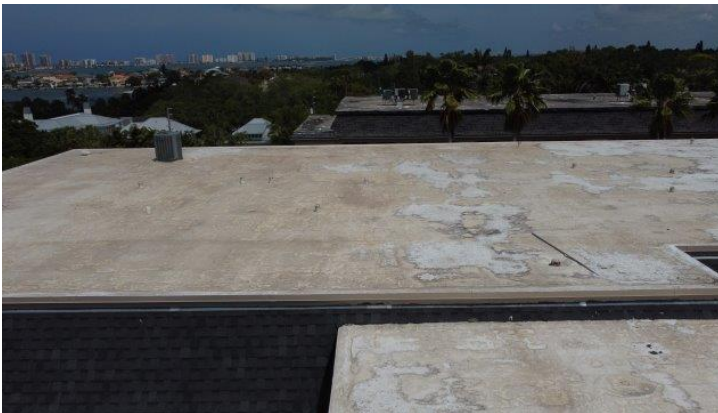
Roof Construction

- 1. Roof Covering:** **FBC Equivalent**
Comments: The flat roof was replaced in 2003. The roof permit was confirmed and the permit number is CB275208. A roof coating was installed in 2010. The mansard roof covering was replaced in 2022. The permit was confirmed and the permit number is EBP-22-19311. This roof was verified as meeting the building code requirements outlined on the OIR 1802 form.
- 2. Roof Deck Attachment:** **Level A**
Comments: Inspection verified 1/2" plywood roof deck attached with 6d nails at a minimum of 6" on the edge & 12" in the field.
- 3. SWR:** **No**
Comments: No SWR verified.
- 4. Opening Protection:** **None or Some Glazed Openings**
Comments: No opening protection verified at the time of inspection.
